CHAPTER 11 – CORROSION ASSESSMENT

11.1 Introduction

A corrosion and durability assessment of key water and wastewater facilities operated by GWA was performed to assess the general integrity of the utility assets from a corrosion perspective. Subsequently, various laboratory examinations and analysis were carried out on a number of soils, bedding material and steel samples. Consequently, the assessment provides a general overview of major asset classes rather than a detailed examination of component assets.

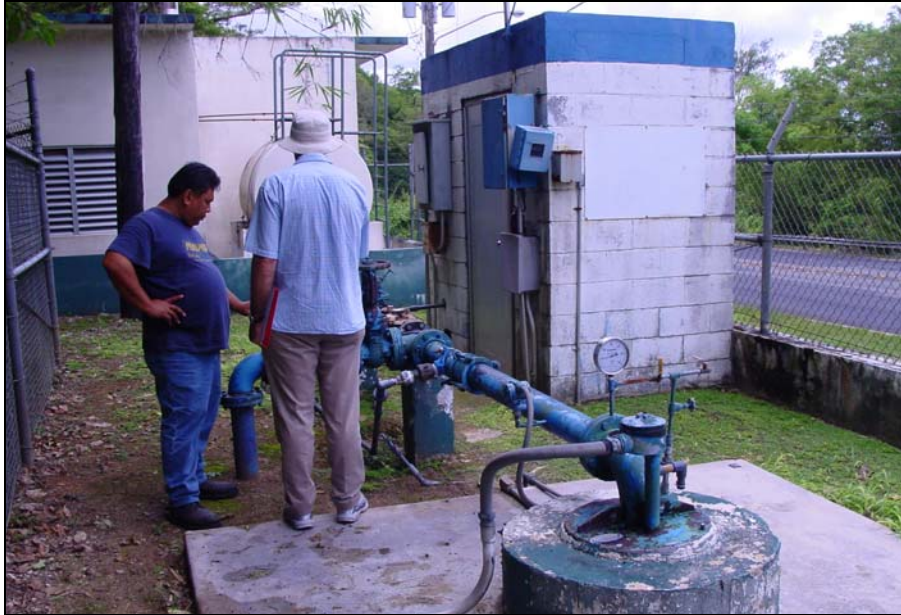
Figure 11-1 – Deep Well PS A-25

A general view of deep well PS A-25 showing pipework from well and chlorine tank room. Building in background is power authority-owned substation with backup generator.

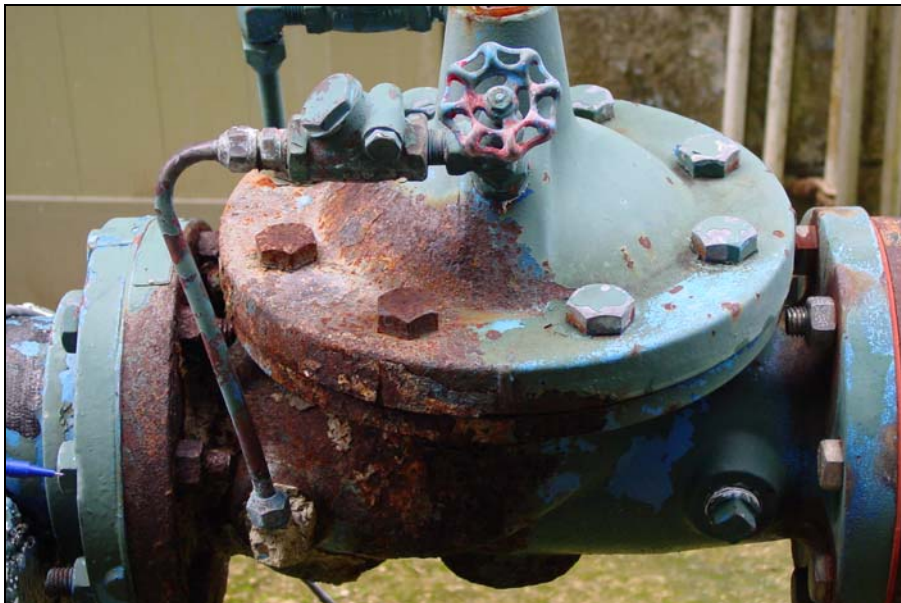
Figure 11-2 – Surface Corrosion on Pipework Flange

Figure 11-1 overleaf shows a general view of PS A-25 while Figure 11-2 shows some superficial corrosion on the flanges.

- In general, all fittings and pipelines examined were in good condition with only some superficial corrosion on, in particular, the flanges.

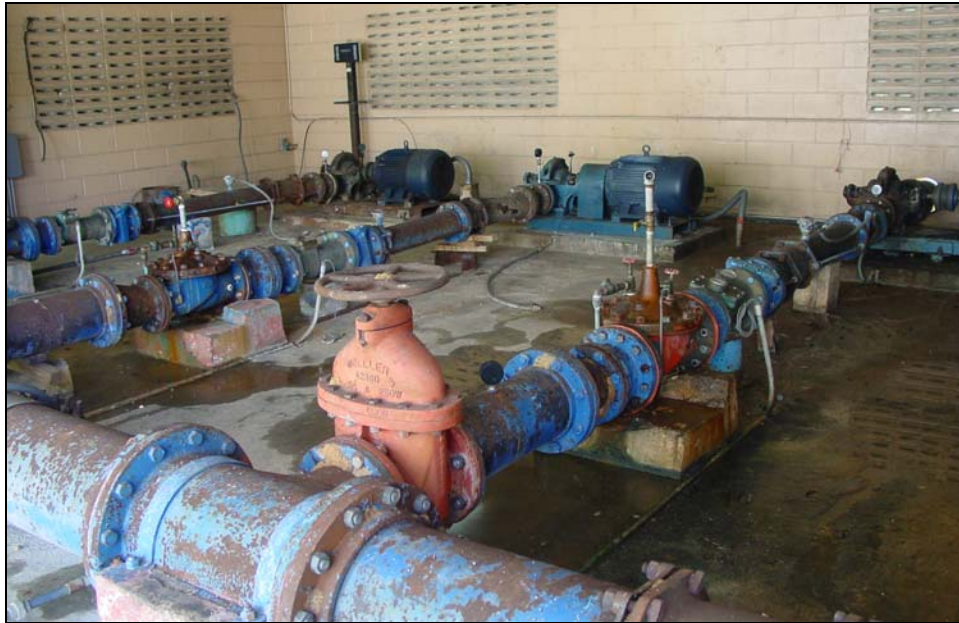
Figure 11-4 – Internal View of PS Pipe Layout

- In general all the light gauge fittings such as switchboards and light fittings were badly corroded, however, the pipework and fittings were in good condition with only superficial corrosion.
- It was noted that this station is within a half mile of the ocean and therefore subject to salt deposit.
- Some of the motor shafts were uncovered and this presents a serious safety

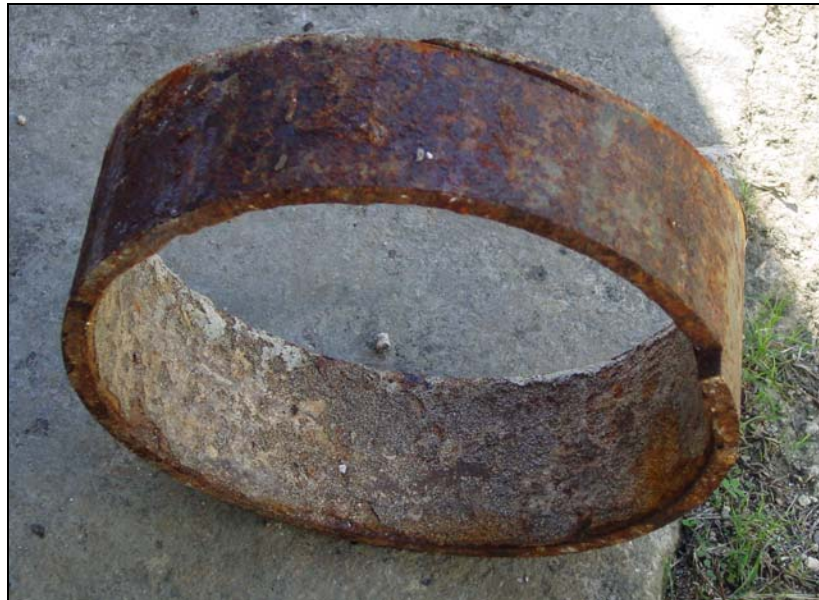
Figure 11-5 – Segment of Old Pipe Stored at the PS

A ductile iron pipe segment showing relatively thin cement mortar lining.

- It was noted that the relatively new switchboard already had some surface staining due to corrosion.
- Some old pipe fittings were stored in the pump station and it was noted that the cement lining was very thin despite the fact that the external surface was only mildly corroded. This may or may not be a general issue and will be discussed in Section 3.14.

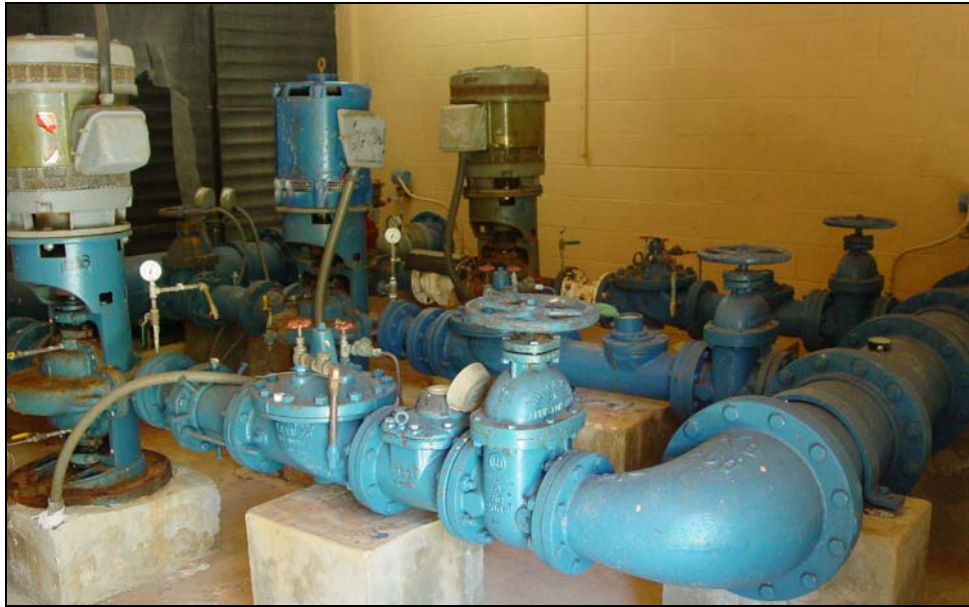
Figure 11-7 – Pipework

A general arrangement of pipework.

- Both structures and pipework were all in good condition, with no evidence of more than superficial corrosion.
- No. 3 pump had an overhead power supply, which although secure presents a safety hazard.

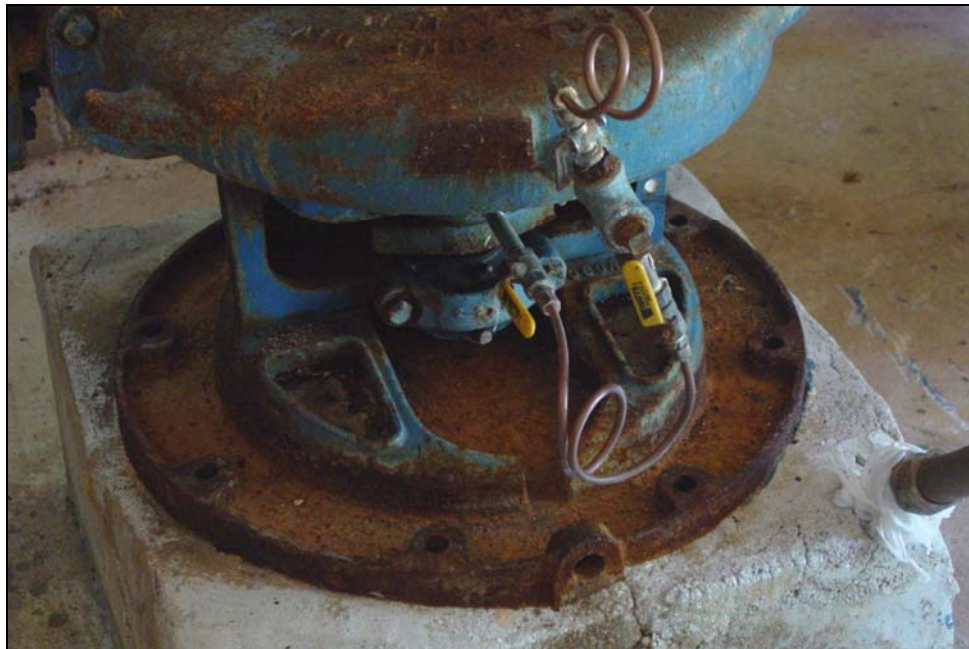
Figure 11-8 – Pump Supports

Pump base plate not bolted to concrete foundation.

- There were no hold down bolts on all three pumps. The base plates were not secured to the concrete foundations and are only restrained by self weight and the pipe connections.

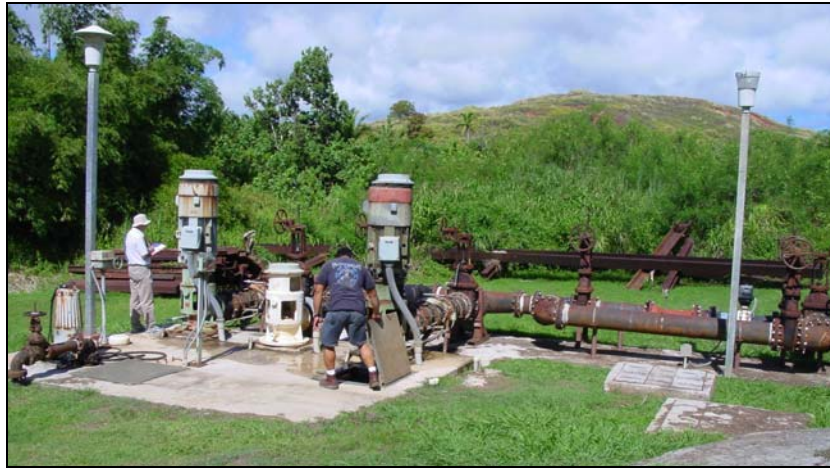
Figure 11-10 – Intake Pumps

A view of the two pumps at the intake works

- There are two pumps of 200 horse power (HP) operating as duty/standby with a spare mounting for an additional pump if required. The pipes and fittings were in good condition with some superficial corrosion. There was evidence of active

- It was clear from the topography of the area that the pumps are in the floodplain and the motors are therefore exposed to flood damage. The operators advised us that there had been three instances of water near or over the pump structures in recent years.
- The switch and power rooms were all in good condition.

Evaluate the risk to supply in regard to the level of the pumps. This may comprise a basic hydrology study to determine the frequency of flooding and an assessment of the consequences of loss of service and time required to replace flooded pumps.

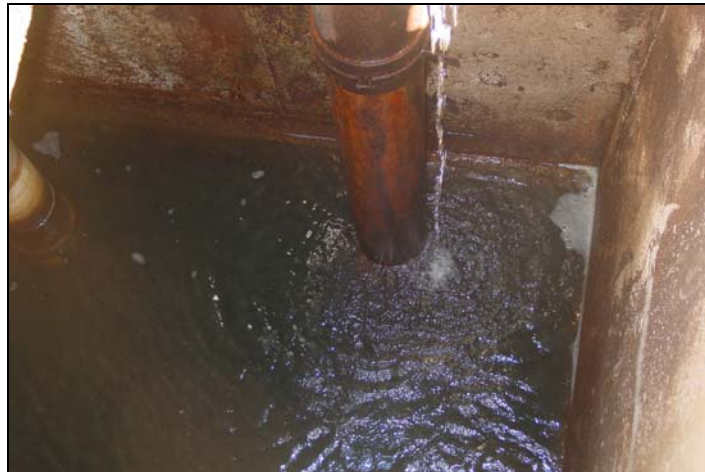
Figure 11-11 – Concrete Intake Pit

Note good condition of concrete.

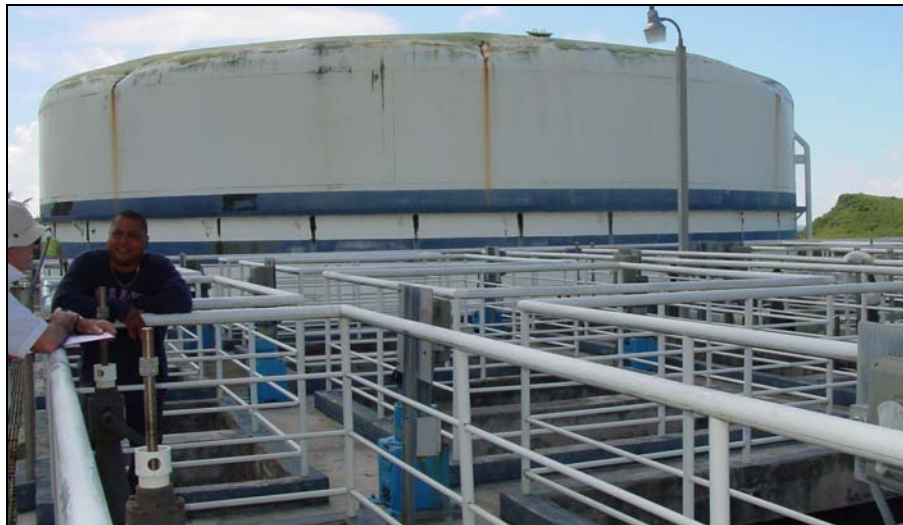
Figure 11-12 – Ugum WTP

General view of Ugum WTP including storm damaged clear water tank.

- The clear water tank walls appeared satisfactory from the outside. However, no internal inspection was possible as the reservoir was full at the time. The failed roof section was also inspected and it was noted that there were severe crimps at the wall to roof section that we assume to be local to a roof beam. There was a substantial depression in the roof, annular in shape. Further, the roof was unstable and deflected substantially under the weight of the inspecting team. It was suggested that this damage was incurred at the last typhoon. It is strongly recommended that this roof be stiffened as it is likely that it could fail in the next major wind event.

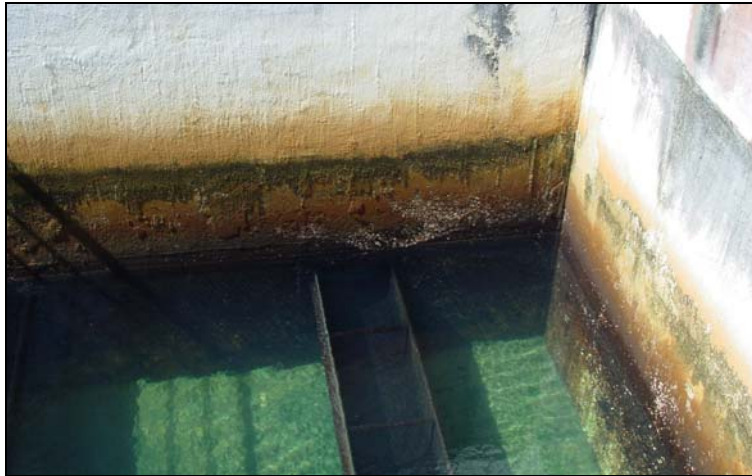
Figure 11-13 – Filtration Tank

Filtration tank showing discolored but otherwise sound concrete.

- The sedimentation tank had minor cracking and organic growth on the walls.
- The filter had some areas of exposed aggregate, probably due to the slightly low pH at this part of the process. Further there was some minor corrosion on pipework in this area. This was not considered serious, but should be monitored.

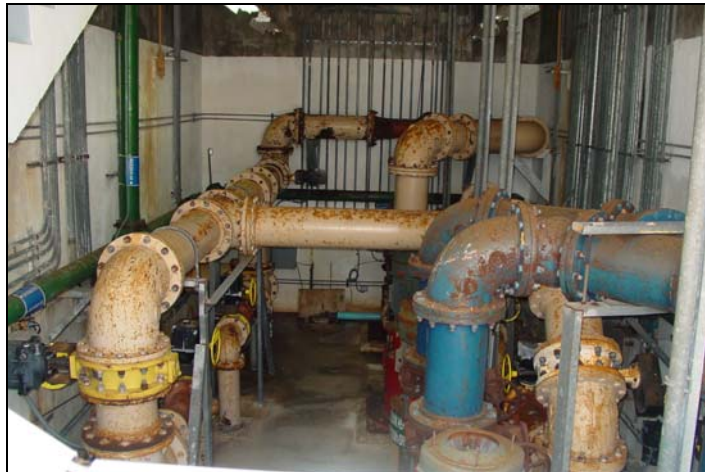
Figure 11-14 – Pipe Gallery Under Control Room

- The tank and pipe gallery under the control room appeared to be in reasonable condition. However, it was noted that there had been instances of leaking chlorine gas and localized areas of corrosion – particular at the southern end of the room with an open hatch cover. Further, there was evidence of loss of durability of the concrete and corrosion of the pipework near this hatch.

Investigations should be undertaken as a matter of urgency to confirm if there are defects in the chlorine injection system.

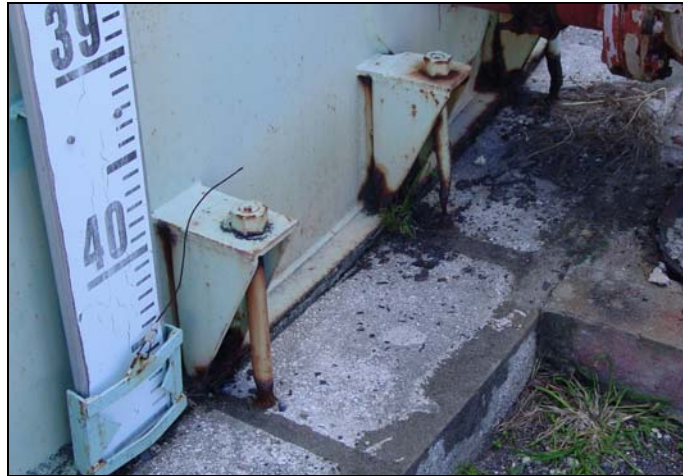
Figure 11-18 – Hold-Down Bolts on Reservoir

Picture shows extensive corrosion and total failure of hold down bolts near concrete base.

- The reservoir was externally only in average condition. Principally, the outstanding issue was the almost total disintegration of the hold-down bolts (see Figure 11-18). Almost 70% plus of these bolts had corroded to failure at the concrete/steel interface.
- The reservoir external coating generic type could not be identified as details were not available, although it is probably an alkyd of some type. The coating was badly chalked and had a coating thickness of 120-180 μm .
- Due to unavailability of ladders the roof could not be inspected. Similarly, it was not possible to inspect the internal surfaces of the reservoir as it was in service.
- The high level tank, built in 1994, had high gloss levels in the unspecified paint and a measured thickness of 300 μm . However, there were heavily corroded areas at the legs and turnbuckle-style wind braces. The ladder of the elevated

Replacement of the hold-down bolts be immediately undertaken if a structural examination demonstrates empty reservoirs are in jeopardy in typhoon conditions.

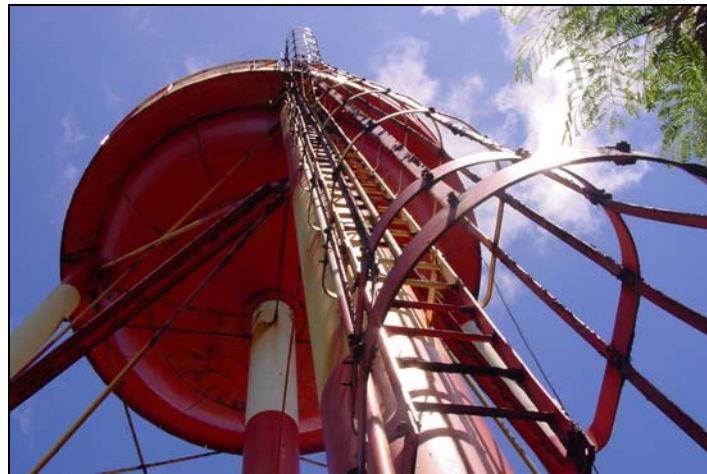
Figure 11-19 – View of Underside of High Level Tank

Picture shows view of corroded ladder and supports on high level tank.

tank was badly corroded (Figure 11-19) and unsafe for use. Work is required to bring these structures up to acceptable levels.

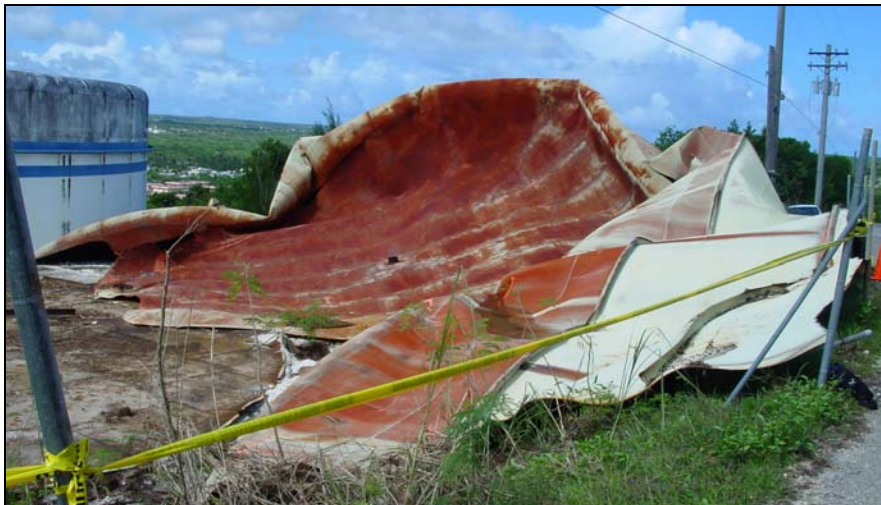
Figure 11-20 – Part of Walls and Roof of Collapsed Reservoir

- A vertical failure up the wall and across the roof at about the third point on the roof plan area.
- A circumferential failure at the bottom strake to floor plate joint.
- All hold down bolts had been pulled out of the concrete ring beam. In the majority of the observable sections this appeared to be a spalling failure in the concrete due to lateral loading from the hold down bolts.
- Major structural damage to the adjacent pump house due to impact with the shell of the reservoir. This house was approximately 60 feet from the base of the reservoir.
- Substantial pitting (exceeding 4 mm in depth) on parts of the wall (see Figure 11-25), repeated on most of the internal lower strakes that could be examined.
- Evidence of poor weld penetration at the floor to wall joint.
- No evidence of underfloor CP installation remained.

- The failure was initiated at an area of severely corroded wall strake at about 6 feet above the base. In structural terms this approximately coincides with the level of maximum hoop load. That is, the moment restraint provided by the floor to wall weld is negligible at this height and the tank behaves as a pure hoop structure.

- We consider that the incremental load that caused failure came from high water levels but recognize the possibility of pressurizing. In discussing the operation of the reservoir and pumps with GWA staff we saw this as a low probability scenario. We also note that the wall thickness' are significantly lower than what would be considered current standard practice, and the steel is possibly more brittle than equivalent mild steel.

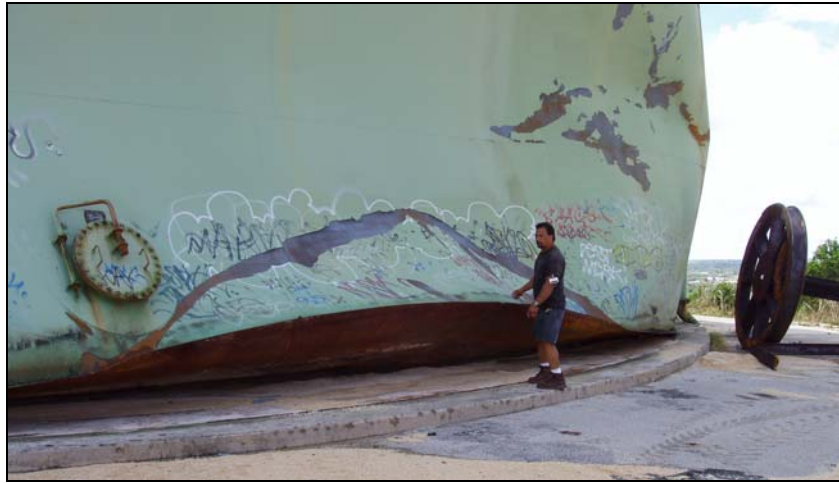
Figure 11-21 – Adjacent 2 mg Damaged Reservoir

The 2 mg Reservoir suffered damage as shown in Figure 11-21 as a result of the collapse of No. 1 Reservoir. We did not observe any internal CP systems on this reservoir. The opportunity was taken to collect a sample of the bedding material used for under floor support for this reservoir in order to test for possible corrosivity.

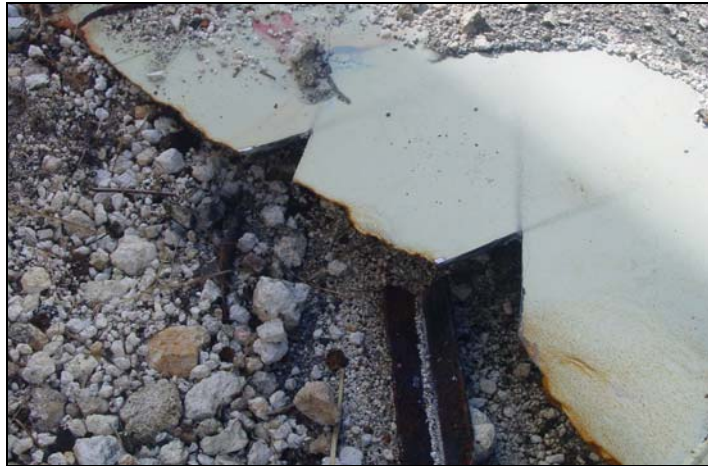
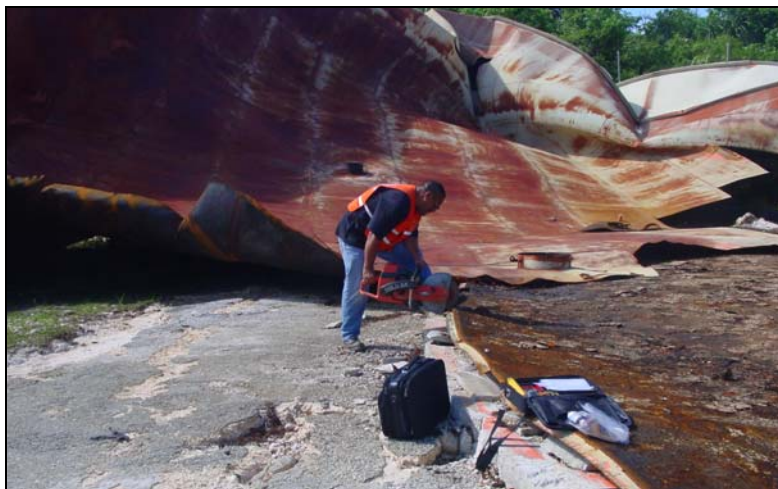
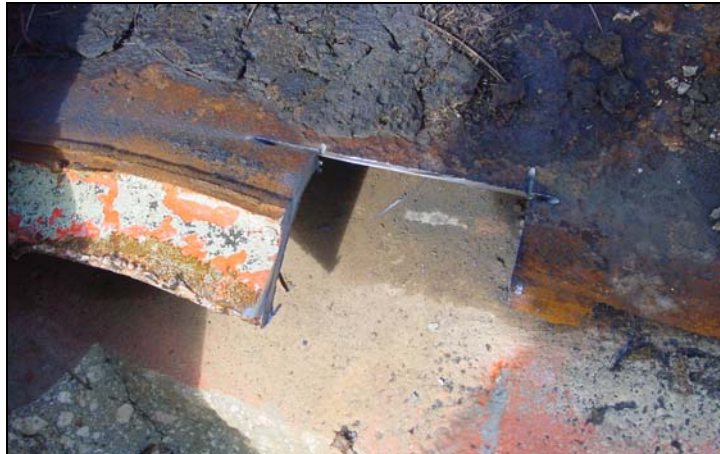
Figure 11-22 –Collapsed Reservoir Wall Showing Positions of Sample Removed for Analysis

A laboratory examination of the steel samples taken from the failed reservoir (see Figures 11-22 to 11-24) has been undertaken and the results are included as Exhibit 11A – CCI POPE Investigation Report at the end of this chapter. Several important issues were identified by the report:

- Steel grade was a copper-bearing 'COR-TEN A', a high-strength weathering steel. While not necessarily an incorrect material, use of this grade of steel for water reservoir construction is unusual and is also noted in having poorer impact and brittle fracture characteristics than mild steels or other weathering grades.
- Internal fillet weld showed severe general and pitting corrosion, thus leading to obvious structural weakness.

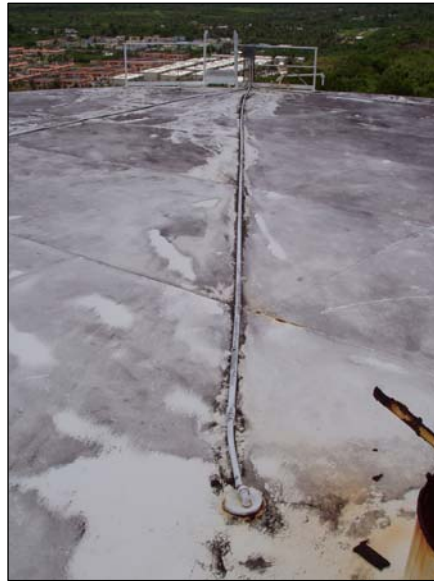
Figure 11-27 – Roof of 3 mg Reservoir

Part of conduit used for (non-operational) cathodic protection.

The top 3 feet of the internal surfaces of the reservoir was observable from the roof hatch and a coating was observable. Due to the poor condition of the internal ladder further access was not possible. There was clear evidence of some attempt to fit internal impressed current CP to this reservoir (Figure 11-26) but as the transformer/rectifier (T/R) unit was missing and the anode array was incomplete for effective use this was non-operational.

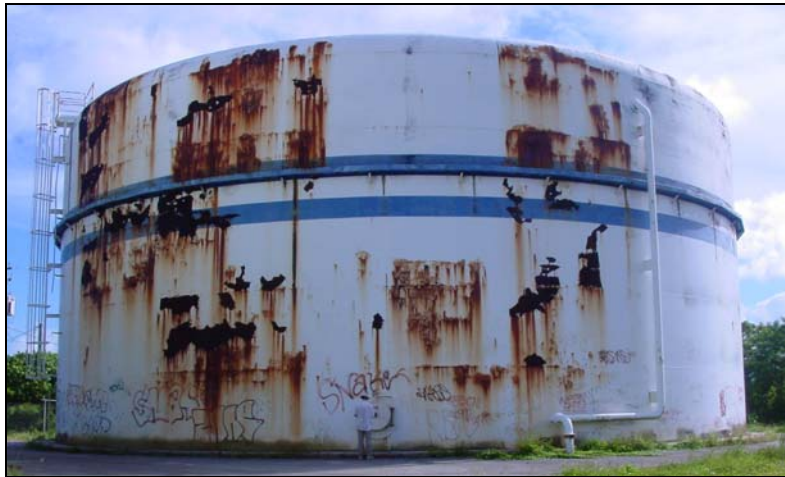
Figure 11-28 – As-Tumbo No. 1 Reservoir

- Both tanks, but particularly No. 1 Reservoir (see Figure 11-28) had extensive surface corrosion. Again, it appeared the original coating had not been applied over a properly prepared surface.
- Hold-down bolts were again in poor condition with approximately 20% having no load carrying capacity.
- A number of CP connections were found (e.g. Figure 11-30), which presumably are for under-floor CP. No test points were found that would be required to test the effectiveness of such a system. As mentioned previously, an underfloor CP system is not standard practice for the water industry and probably not required.
- No signs of any CP installations were observed on either reservoir roof which might have indicated protection of the internal surfaces.

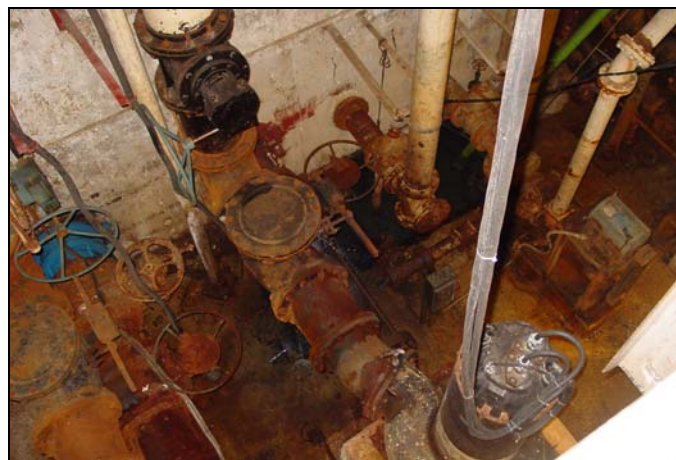
Figure 11-32 – Pump Arrangement Inside Dry Well

Corrosion is largely superficial.

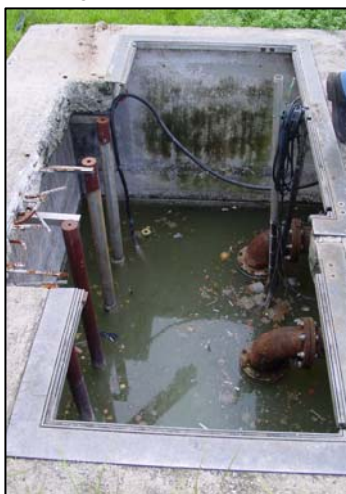
Figure 11-34 – Wet Well

- The wet well structures were in generally good condition although there were no steel hatch covers. We understand that they are being repaired and will be replaced soon.
- The switch room and generator room were structurally sound with fittings observed to be in good condition.
- The security fence was in reasonable condition but is not child-proof and given the open wet well represents a major safety risk.

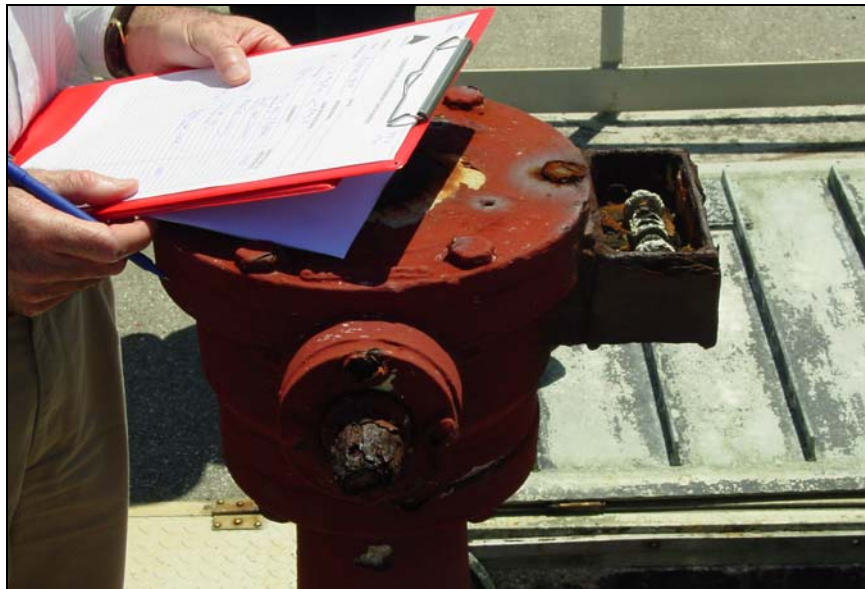
Figure 11-35 – Corrosion of Penstock Gate Valve

- Penstock type gate valves were consistently in poor condition.
- All process pipework was in bad condition with delamination evident.
- Although it was not possible to inspect the concrete soffits, it was reported that the clarifiers and digesters had substantial concrete degradation. This was noted at the outlet drop chamber where significant loss of concrete paste had progressed to at least the centerline of the reinforcing steel (see Figure 11-40).

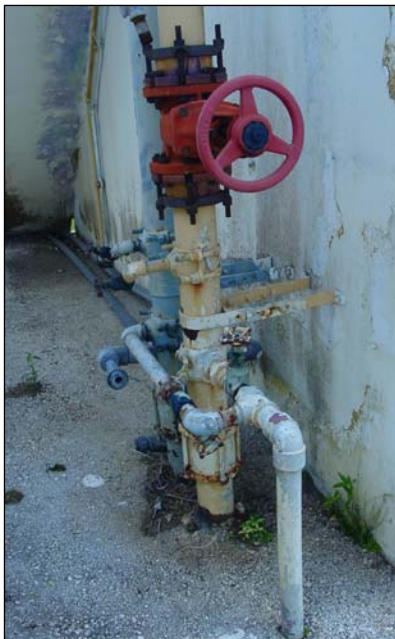
Figure 11-44 – Pipework H₂S Corrosion at Centrifuge Building

- Some evidence of structural damage from recent seismic event.
- The concrete hydraulic surfaces were in a consistently good condition.
- There was minor H₂S affected copper pipes.

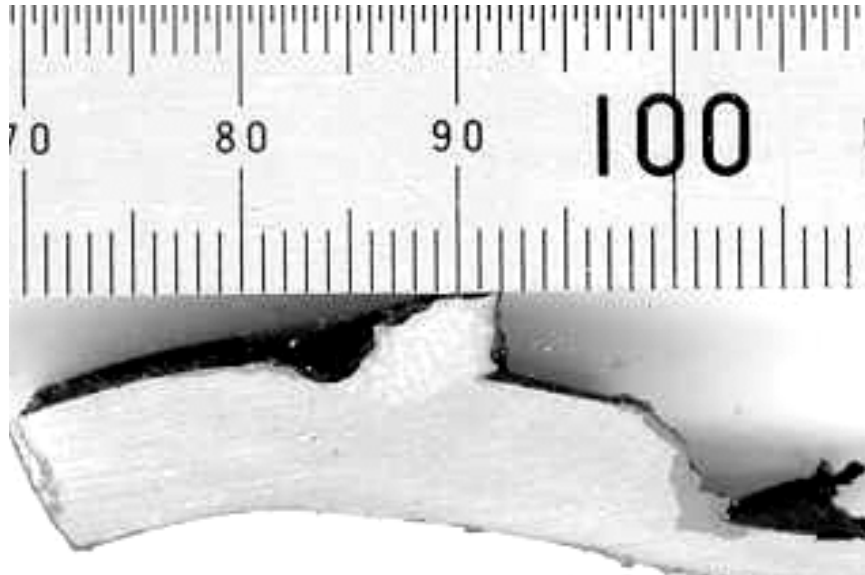
Figure 5
Shows the macro sample removed from a sample from the tank to shell plate weld. The location which the shell plate originally occupied is arrowed. Note the corrosion on the internal fillet weld toe.
