CHAPTER 11 – CORROSION ASSESSMENT

11.1 Introduction

A corrosion and durability assessment of key water and wastewater facilities operated by GWA was performed to assess the general integrity of the utility assets from a corrosion perspective. Subsequently, various laboratory examinations and analysis were carried out on a number of soils, bedding material and steel samples. Consequently, the assessment provides a general overview of major asset classes rather than a detailed examination of component assets.

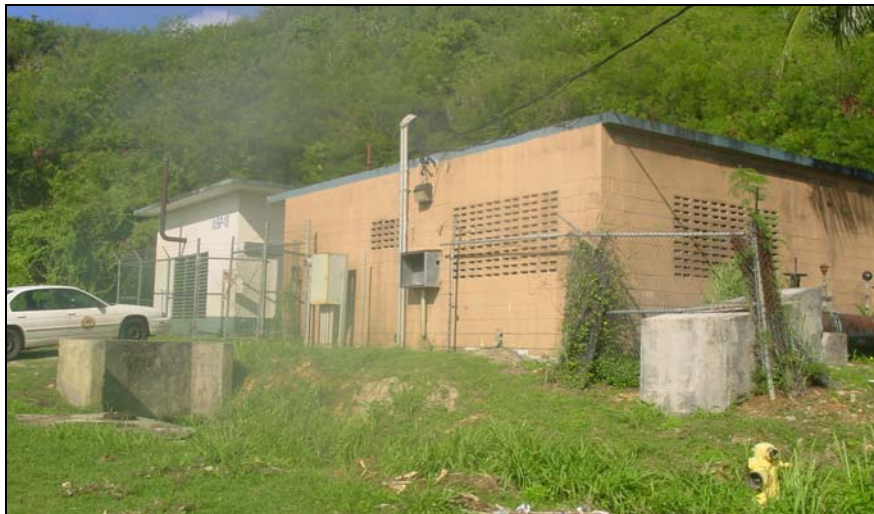
Figure 11-3 – Pago Bay Water PS

The WBPS at Pago Bay consisted of a reinforced concrete switchroom and an open-sided reinforced concrete pump room. Figure 11-3 below shows a general view of the pump station while Figure 11-4 gives a view of the pipe layout in the pump room. Figure 11-5 shows a segment of old pipe stored at the pump station.

- In general all the light gauge fittings such as switchboards and light fittings were badly corroded, however, the pipework and fittings were in good condition with only superficial corrosion.
- It was noted that this station is within a half mile of the ocean and therefore subject to salt deposit.
- Some of the motor shafts were uncovered and this presents a serious safety

Annually inspect and treat with waterproofing spray electrical fittings, connections and cover boxes showing signs of corrosion. Any critical fitting or one that presents a safety risk should be replaced.

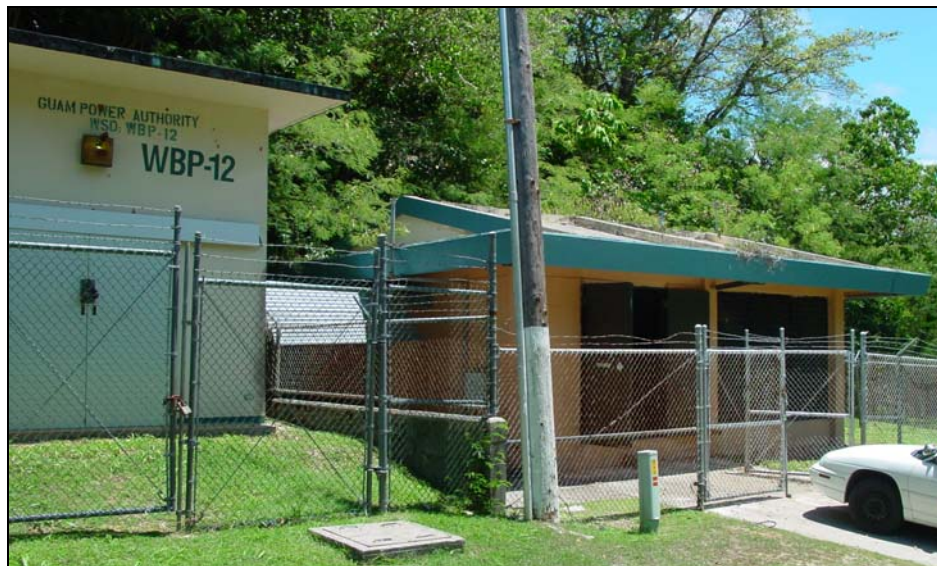
Figure 11-6 – Brigade Bay PS

An external view of Brigade Bay PS.

- Both structures and pipework were all in good condition, with no evidence of more than superficial corrosion.
- No. 3 pump had an overhead power supply, which although secure presents a safety hazard.

Annually inspect and treat with waterproofing spray electrical fittings, connections and cover boxes showing signs of corrosion. Any critical fitting or one that presents a safety risk should be replaced.

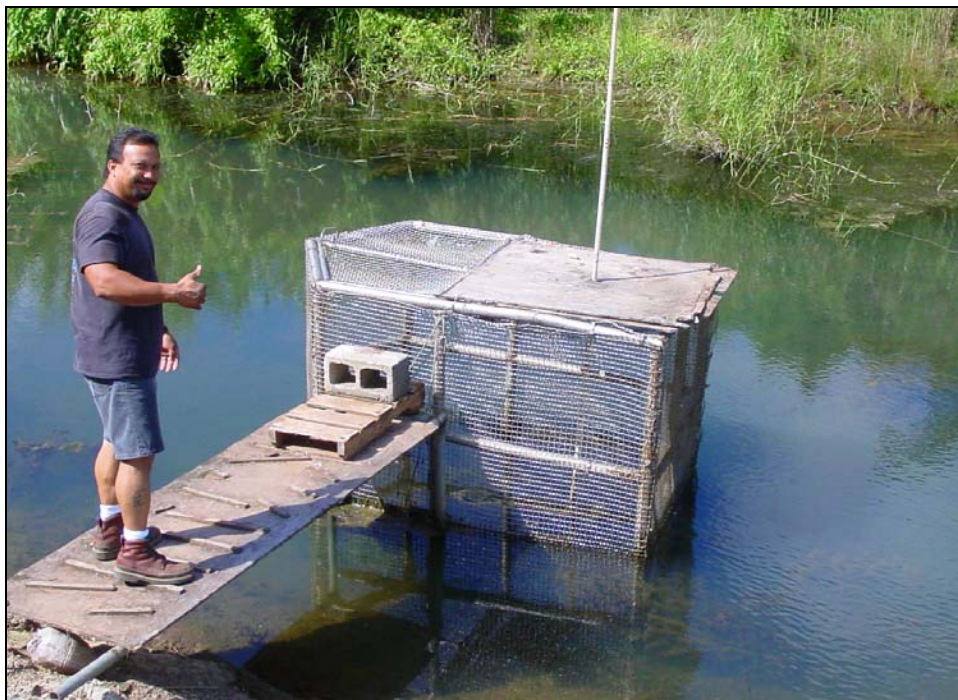
Figure 11-9 – Intake Structure

A general view of weir intake structure.

- The intake structure was encapsulated by stainless steel fencing grid with approximately 100 mm spacing. It is in satisfactory condition, although we were advised that it could become blocked under flood conditions.

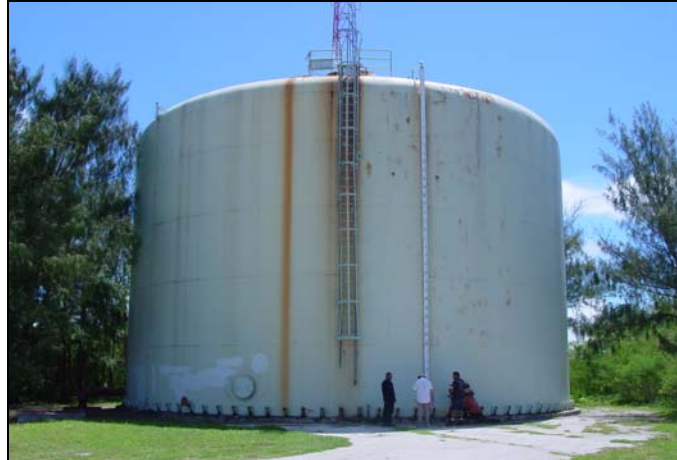
Figure 11-16 –View of Malojloj 1 mg Reservoir

- The reservoir was externally only in average condition. Principally, the outstanding issue was the almost total disintegration of the hold-down bolts (see Figure 11-18). Almost 70% plus of these bolts had corroded to failure at the concrete/steel interface.
- The reservoir external coating generic type could not be identified as details were not available, although it is probably an alkyd of some type. The coating was badly chalked and had a coating thickness of 120-180 μm .
- Due to unavailability of ladders the roof could not be inspected. Similarly, it was not possible to inspect the internal surfaces of the reservoir as it was in service.
- The high level tank, built in 1994, had high gloss levels in the unspecified paint and a measured thickness of 300 μm . However, there were heavily corroded areas at the legs and turnbuckle-style wind braces. The ladder of the elevated

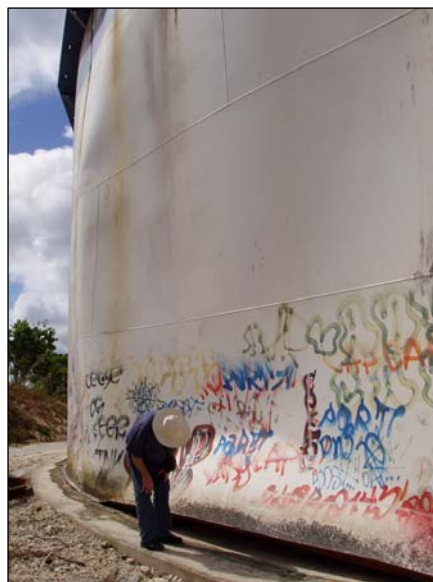
Figure 11-26 – Damage to 3 mg Reservoir

The top 3 feet of the internal surfaces of the reservoir was observable from the roof hatch and a coating was observable. Due to the poor condition of the internal ladder further access was not possible. There was clear evidence of some attempt to fit internal impressed current CP to this reservoir (Figure 11-26) but as the transformer/rectifier (T/R) unit was missing and the anode array was incomplete for effective use this was non-operational.

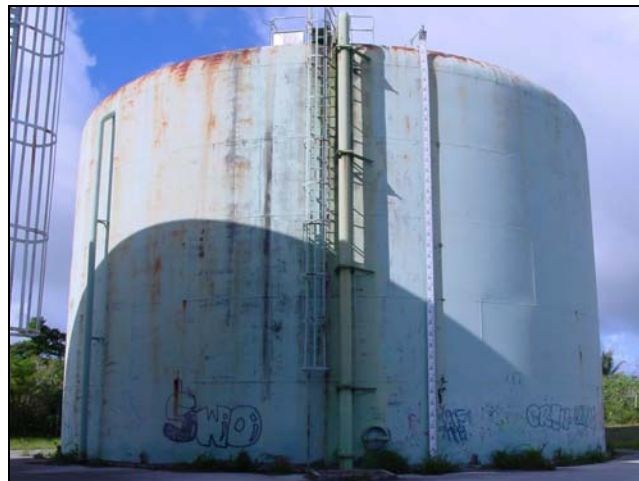
Figure 11-29 – As-Tumbo No. 2 Reservoir

- Both tanks, but particularly No. 1 Reservoir (see Figure 11-28) had extensive surface corrosion. Again, it appeared the original coating had not been applied over a properly prepared surface.
- Hold-down bolts were again in poor condition with approximately 20% having no load carrying capacity.
- A number of CP connections were found (e.g. Figure 11-30), which presumably are for under-floor CP. No test points were found that would be required to test the effectiveness of such a system. As mentioned previously, an underfloor CP system is not standard practice for the water industry and probably not required.
- No signs of any CP installations were observed on either reservoir roof which might have indicated protection of the internal surfaces.

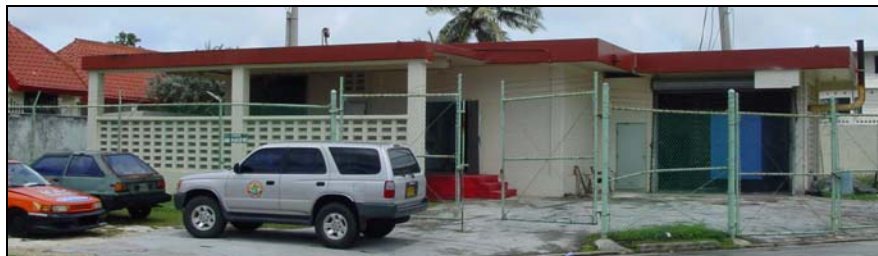
Figure 11-31 – External View of Hagatna STP

This pump station comprised a concrete building with four (4) 100 horsepower ABS pumps, running as two duty and two standby. There is also a sump pump for removing pipework leakage. Figures 11-31 to 11-32 give general views of Hagatna STP.

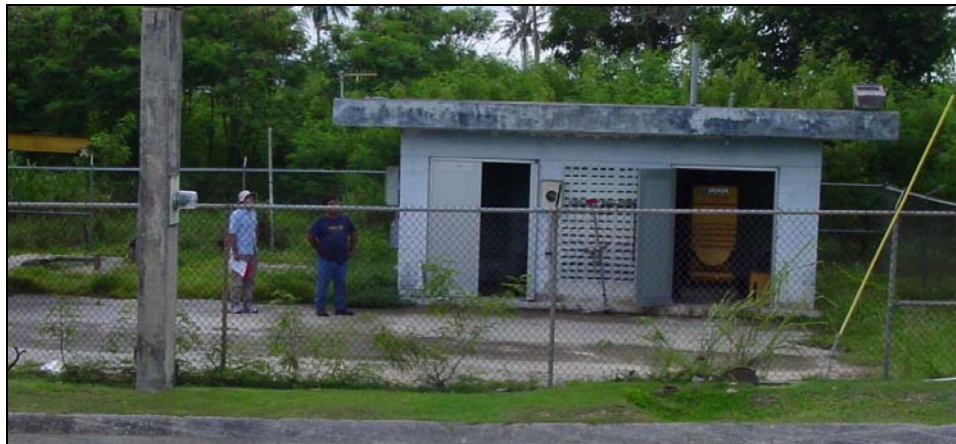
Figure 11-33 – Prison Wet Well Site

Figure 11-33 below shows the position of the switch room and generator room at the wet well site while Figure 11-34 shows the wet well itself.

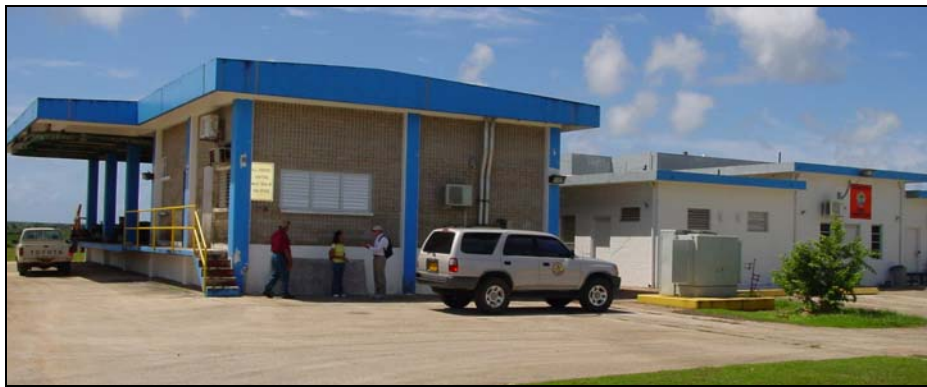
Figure 11-43 – General View of Chlorination, Laboratory and Operational Buildings

- The transfer pump building was in good condition throughout.
- The heater digester/polymer mixing building was in good condition with the exception of major corrosion on the blower ductwork (see Figure 11-44).

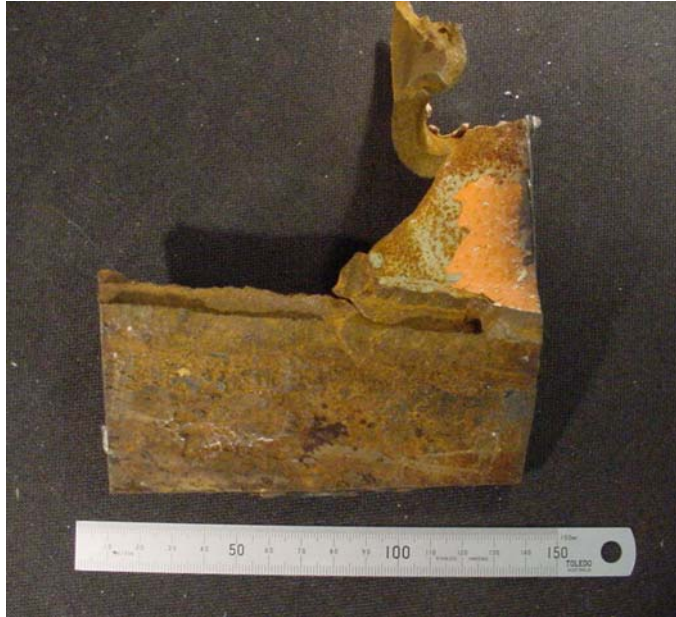
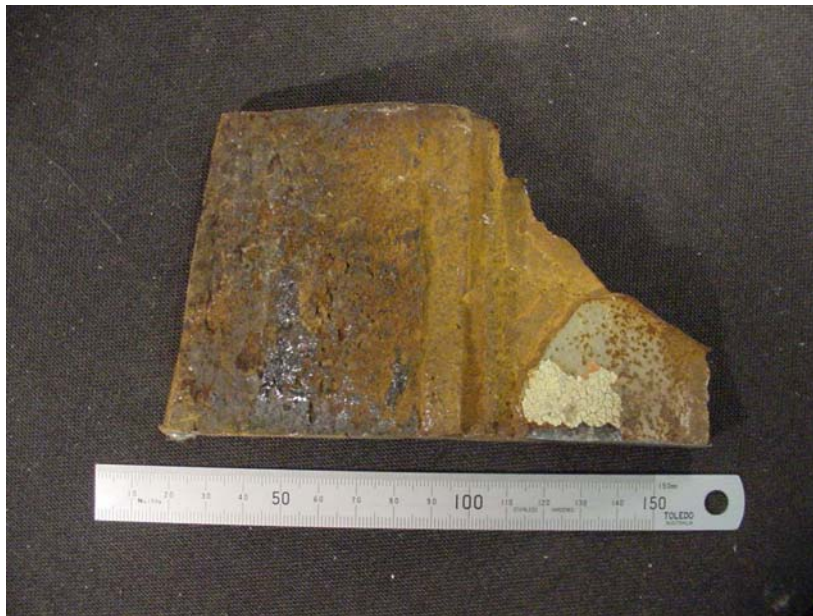
Figures 1 and 2 show the two samples as received for examination. It was evident that the tank had been constructed by fillet welding on both the internal and external sides of the shell/floor connection. Failure of the tank had resulted in the shell plate shearing the welds for most of the length of the samples supplied. Severe internal corrosion of the floor plate was evident. The samples were cleaned in inhibited hydrochloric acid and they are shown in figures 3 and 4 after this cleaning. Severe general and pitting corrosion of the internal fillet weld was revealed.

Figures 1 & 2
Show the two samples received for examination.

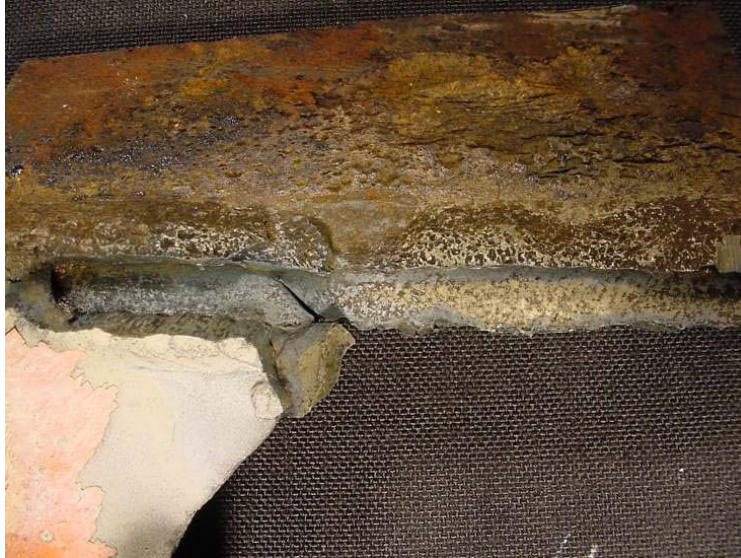
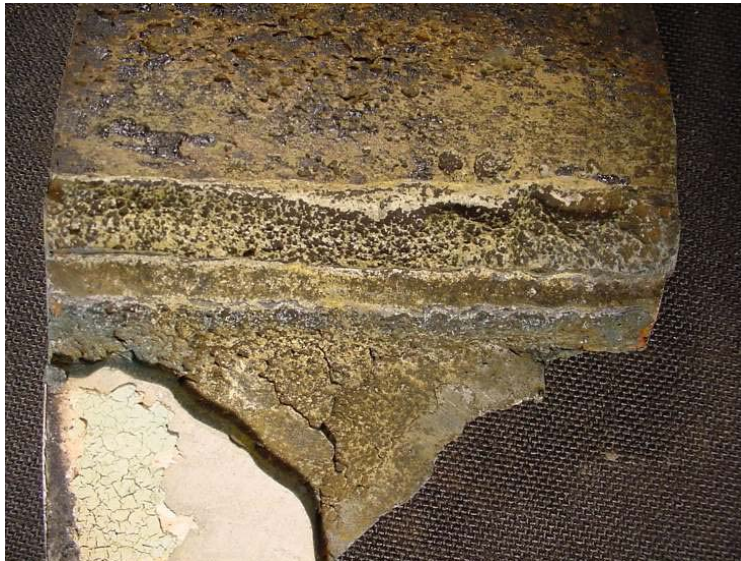
Figures 3 & 4
Show the samples after cleaning in an inhibited hydrochloric acid solution.
