CHAPTER 4 – WASTEWATER COLLECTION SYSTEM

4.1 Introduction

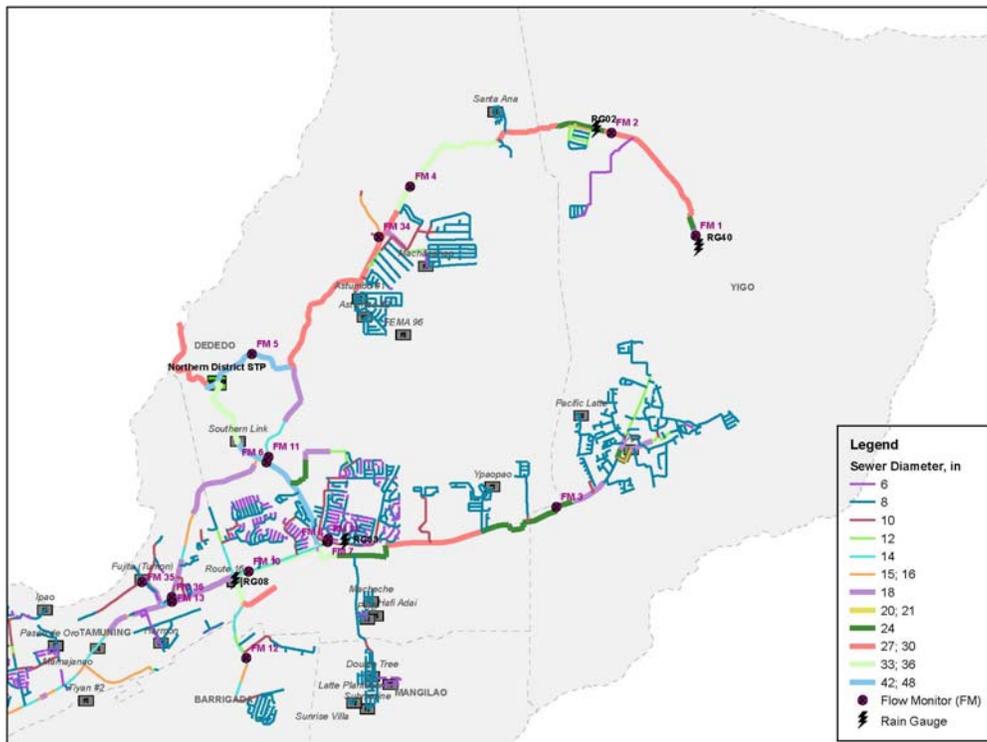
Figure 4-1 – Northern District STP Sewer Network

Due to a lack of available as-built drawings in some areas, the 1968 USGS maps and village parcel maps were reviewed to fill in gaps in the GIS coverage. Because the USGS and parcel maps do not have invert elevations for manholes, the necessary invert data were developed by extrapolation between known points or by assuming slopes based on contour information. Missing rim elevations were estimated from the available contour information. The network resulting from this effort is shown on Figures 4-1 through 4-4.

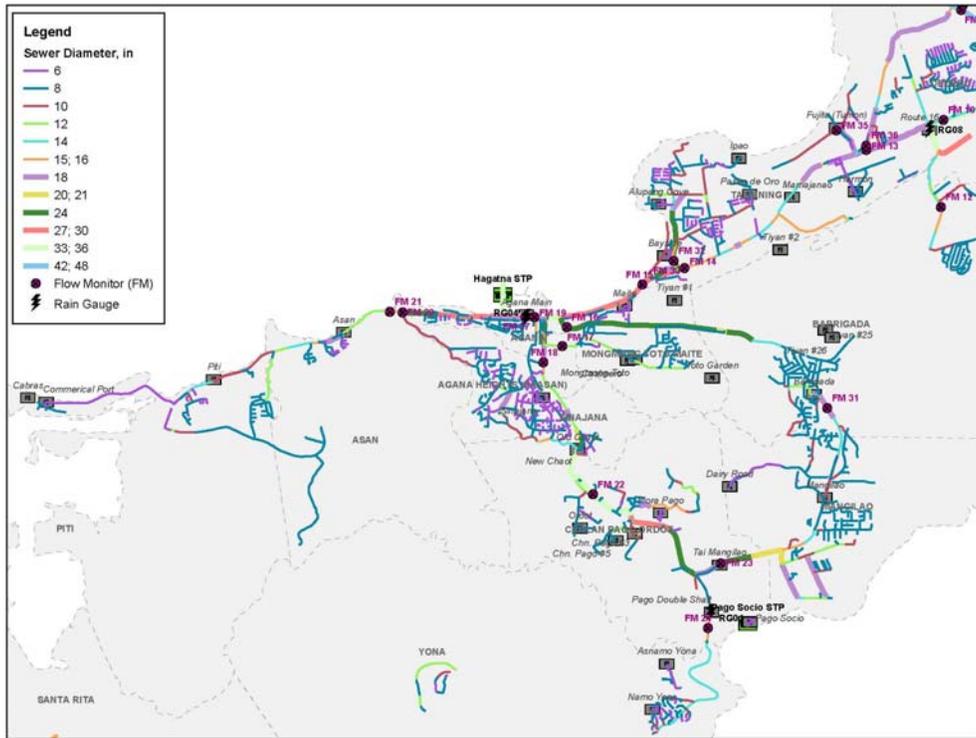
Figure 4-2 – Hagatna STP Sewer Network

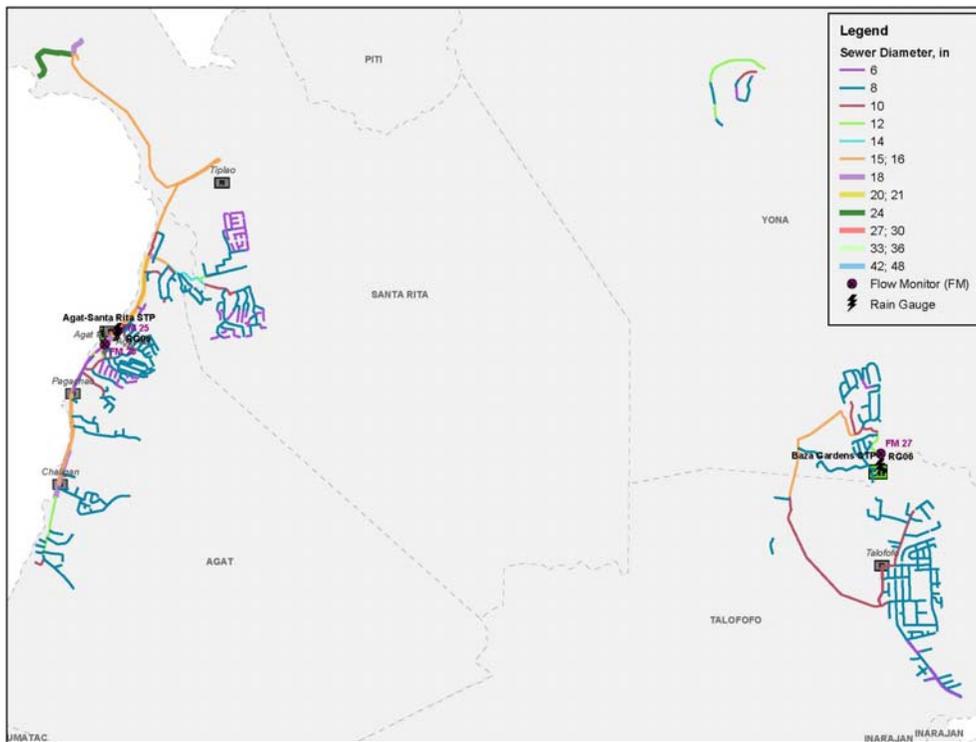
Figure 4-3 – Agat-Santa Rita and Baza Gardens Sewer Networks

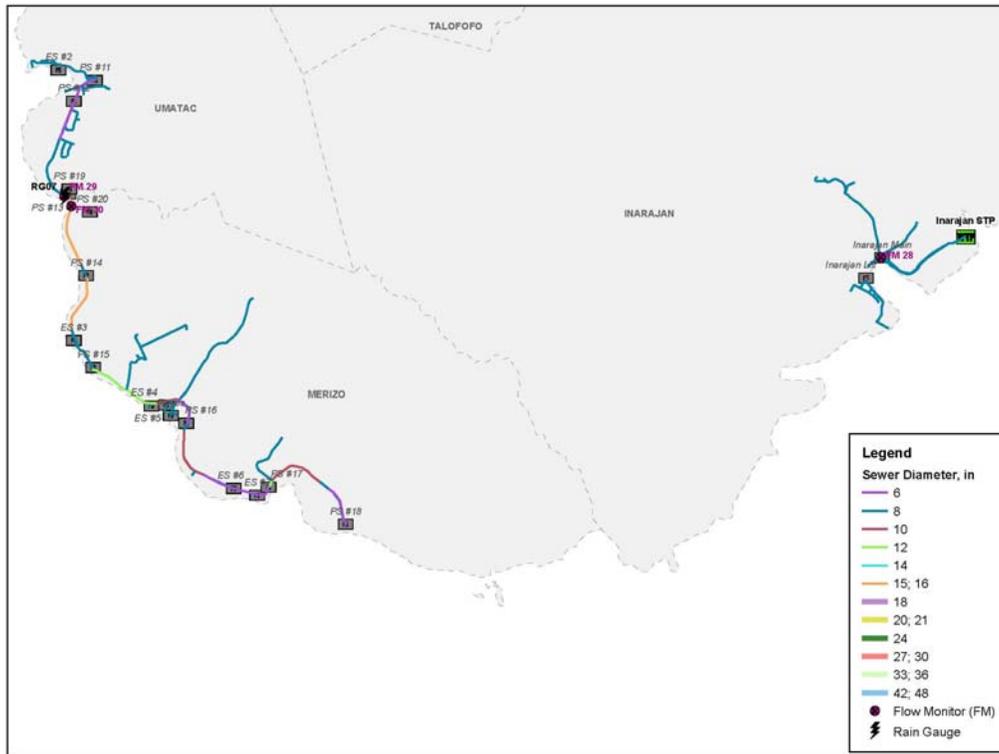
Figure 4-4 – Umatac-Merizo and Inarajan Sewer Networks

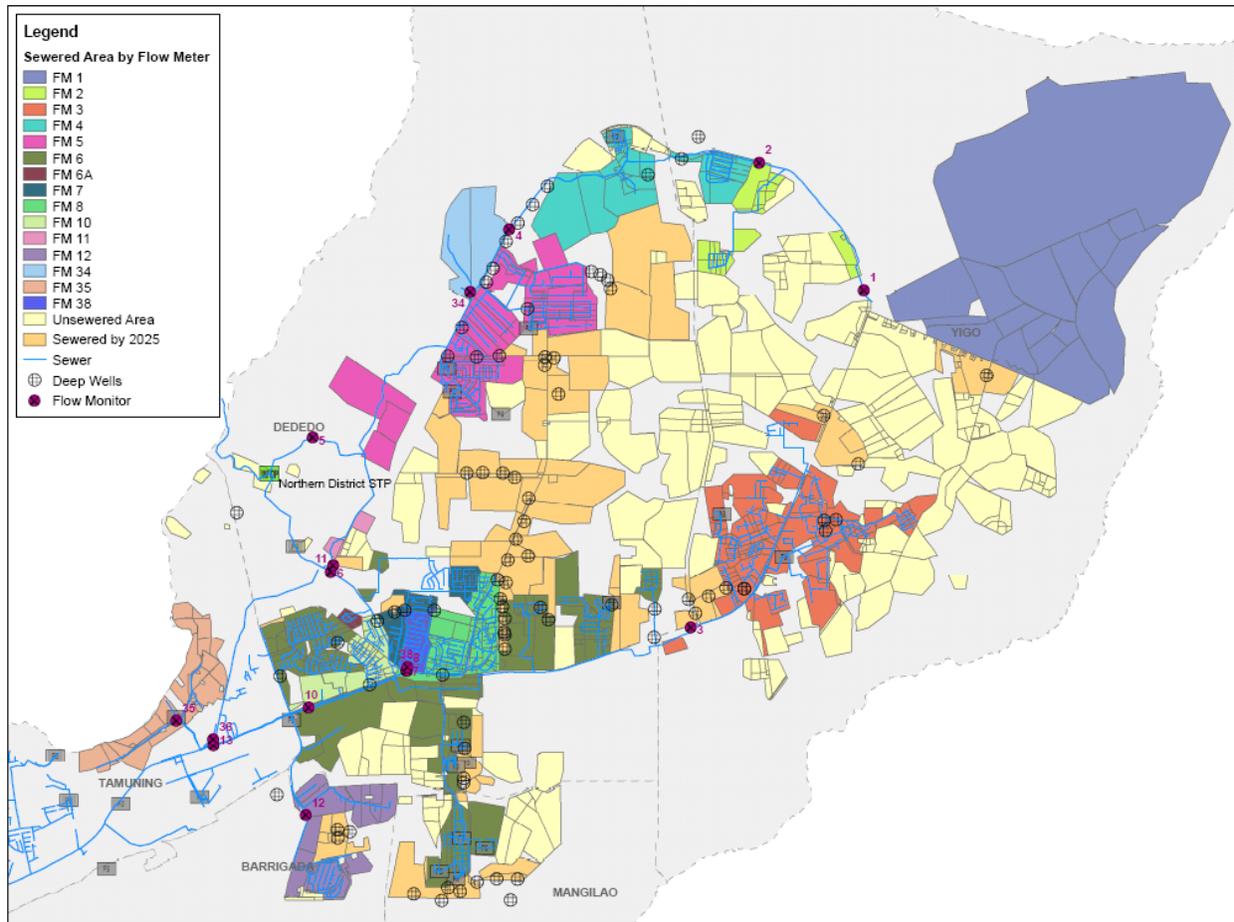
Figure 4-6 – Northern District Developed Areas

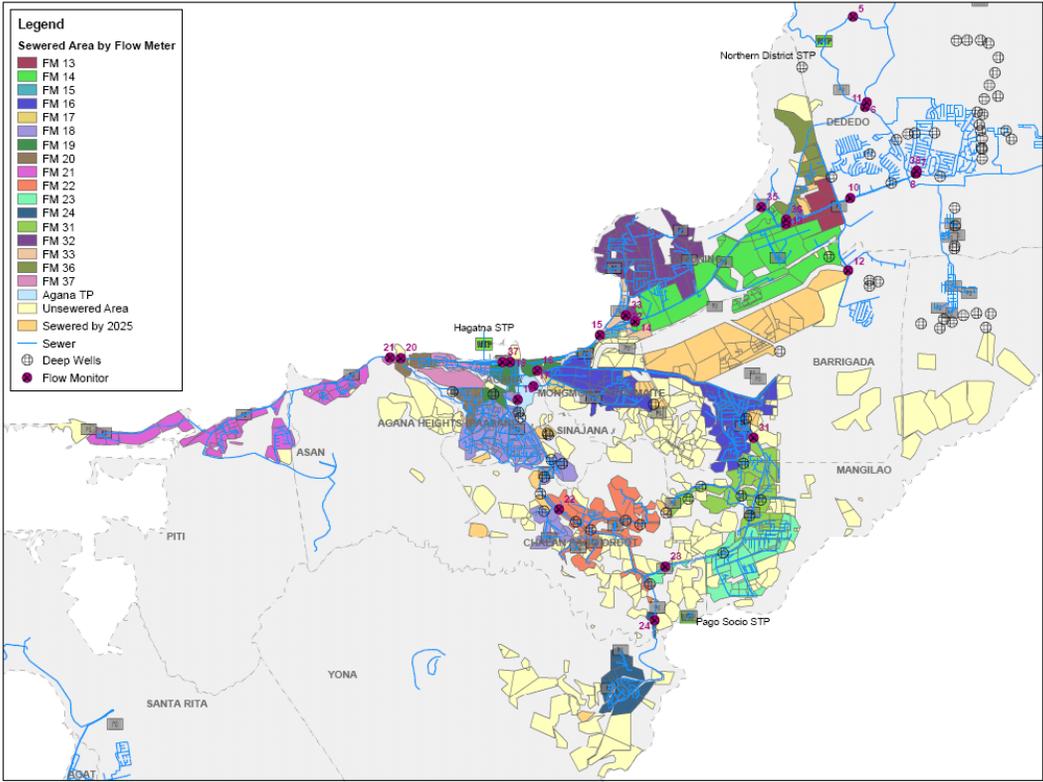
Figure 4-7 – Hagatna Developed Areas

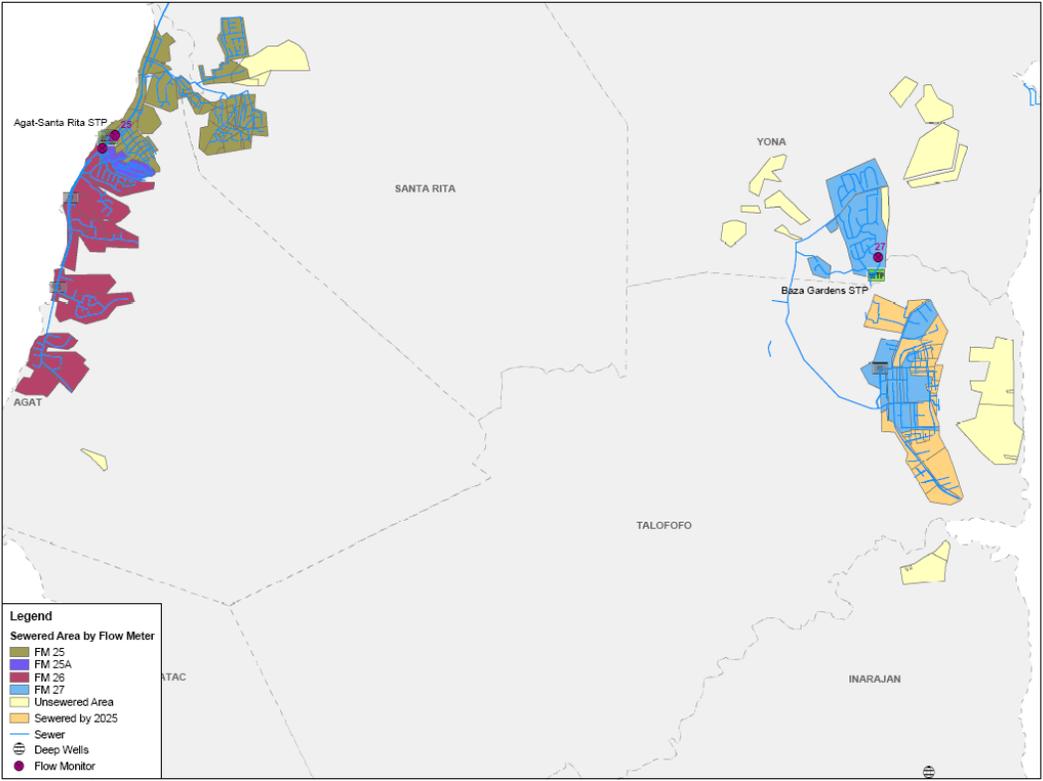
Figure 4-8 – Agat-Santa Rita and Baza Gardens Developed Areas

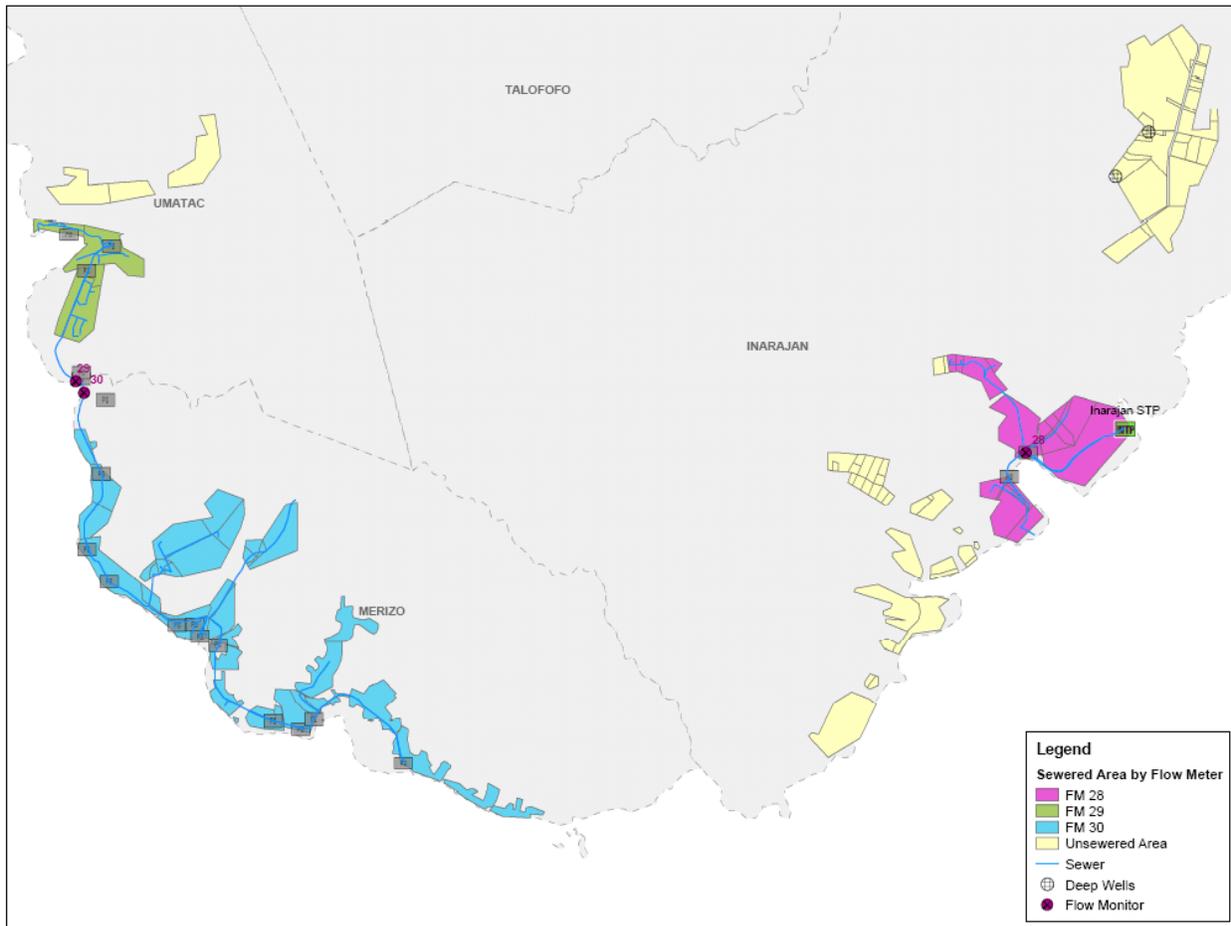
Figure 4-9 – Umatac-Merizo – Inarajan Developed Areas

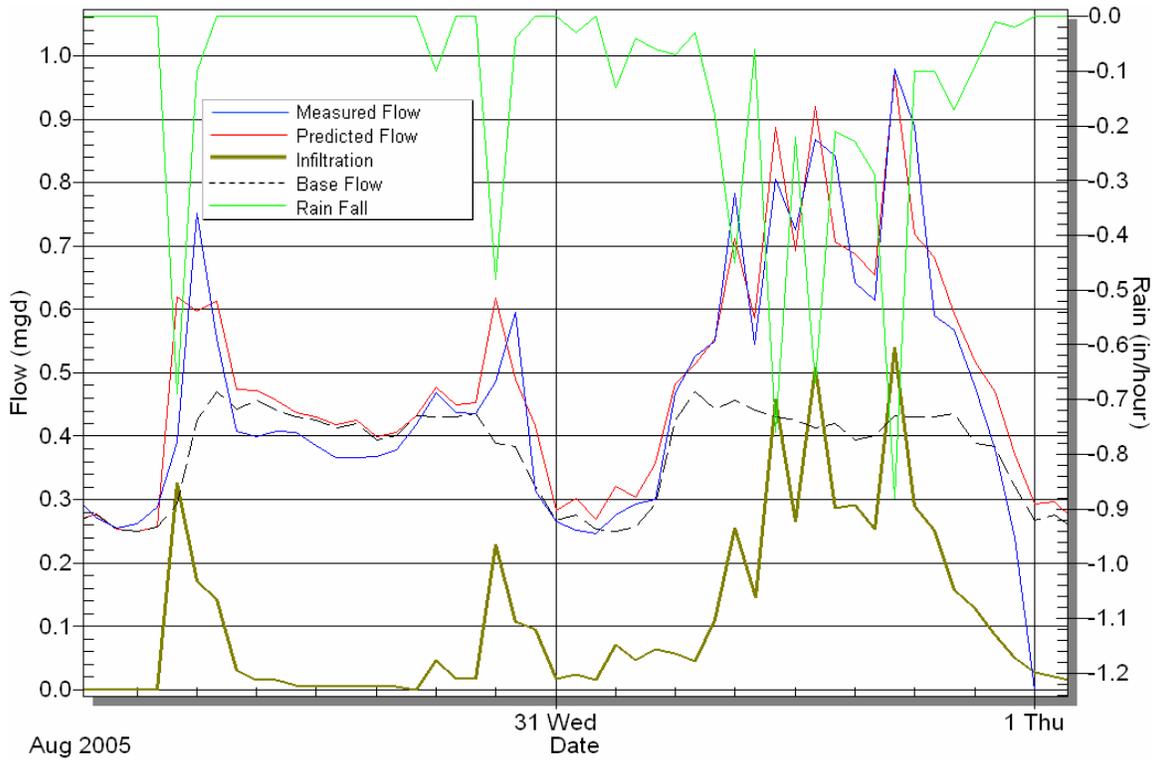
Figure 4-10 – I/I Model Calibration Example, Meter 8

Wet weather flow estimates were derived from the flow and rainfall monitoring program. The flows that occurred during rains associated with typhoon Nabi that passed north of the island at the end of August 2005 were used for development of wet weather flows. The estimated I/I flows (total flow less base flow) that occurred at the flow monitors on the 31st of August were extracted from the monitoring records and used for capacity assessment. I/I models developed in Capacity Assurance Planning Environment (CAPE) were used to estimate I/I for this event at monitors where the record did not include this date. Wet weather flows were also extrapolated to events with higher or lower rainfall than actually occurred using the CAPE I/I models. Figure 4-10 shows an example of the calibration.

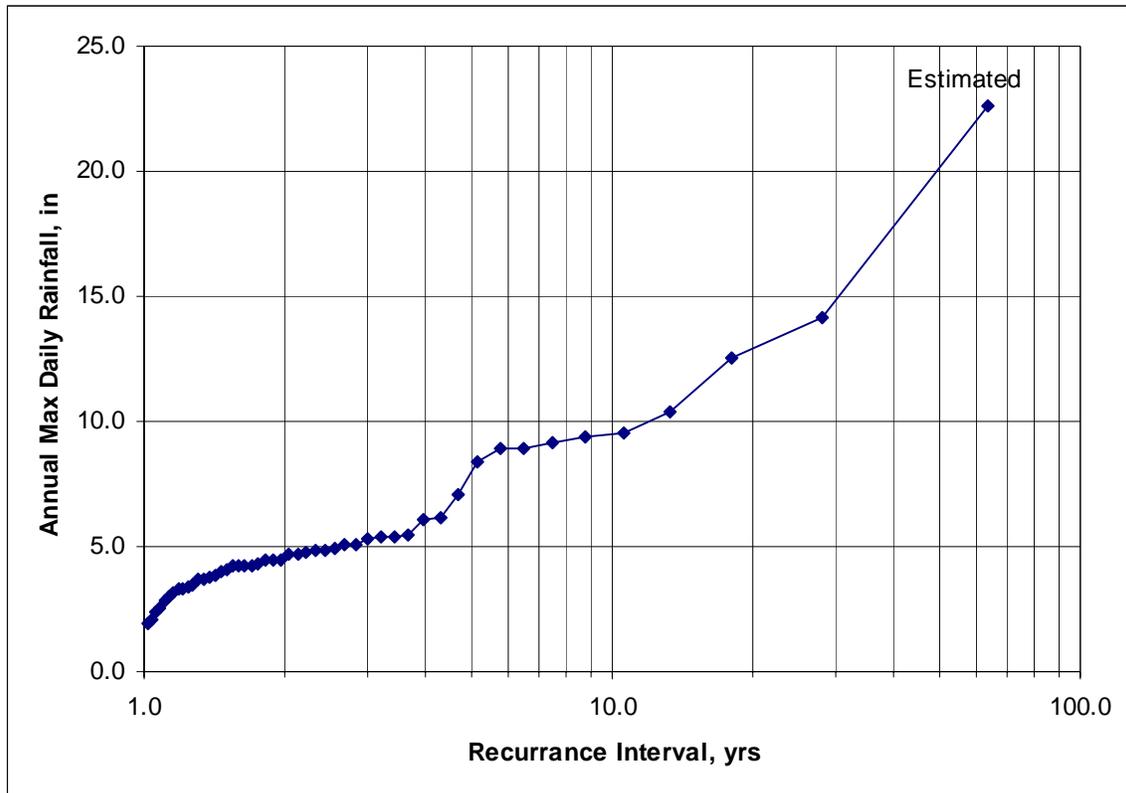
Figure 4-11 – Occurrence Frequency of Daily Total Rainfall for Guam

Long term rainfall data is available from the National Climatic Data Center. Daily rainfall totals are available spanning from 1953 through 2001. Hourly rainfall data are available only from 1984 through 1999. Figure 4-11 shows an occurrence frequency chart of daily rainfall from this data. It is noted that the 10-year daily depth is only 13% higher than the five-year depth. During the monitoring period, approximately five inches of rain fell on the north end of the island on August 31, 2005 with peak hourly intensities up to six inches per hour. Over eight inches fell on the south end of the island with peak intensities over nine inches per hour. Sewer flows in Guam respond significantly to peak hourly intensities, but also depend on antecedent rainfall over the previous 24-hours.

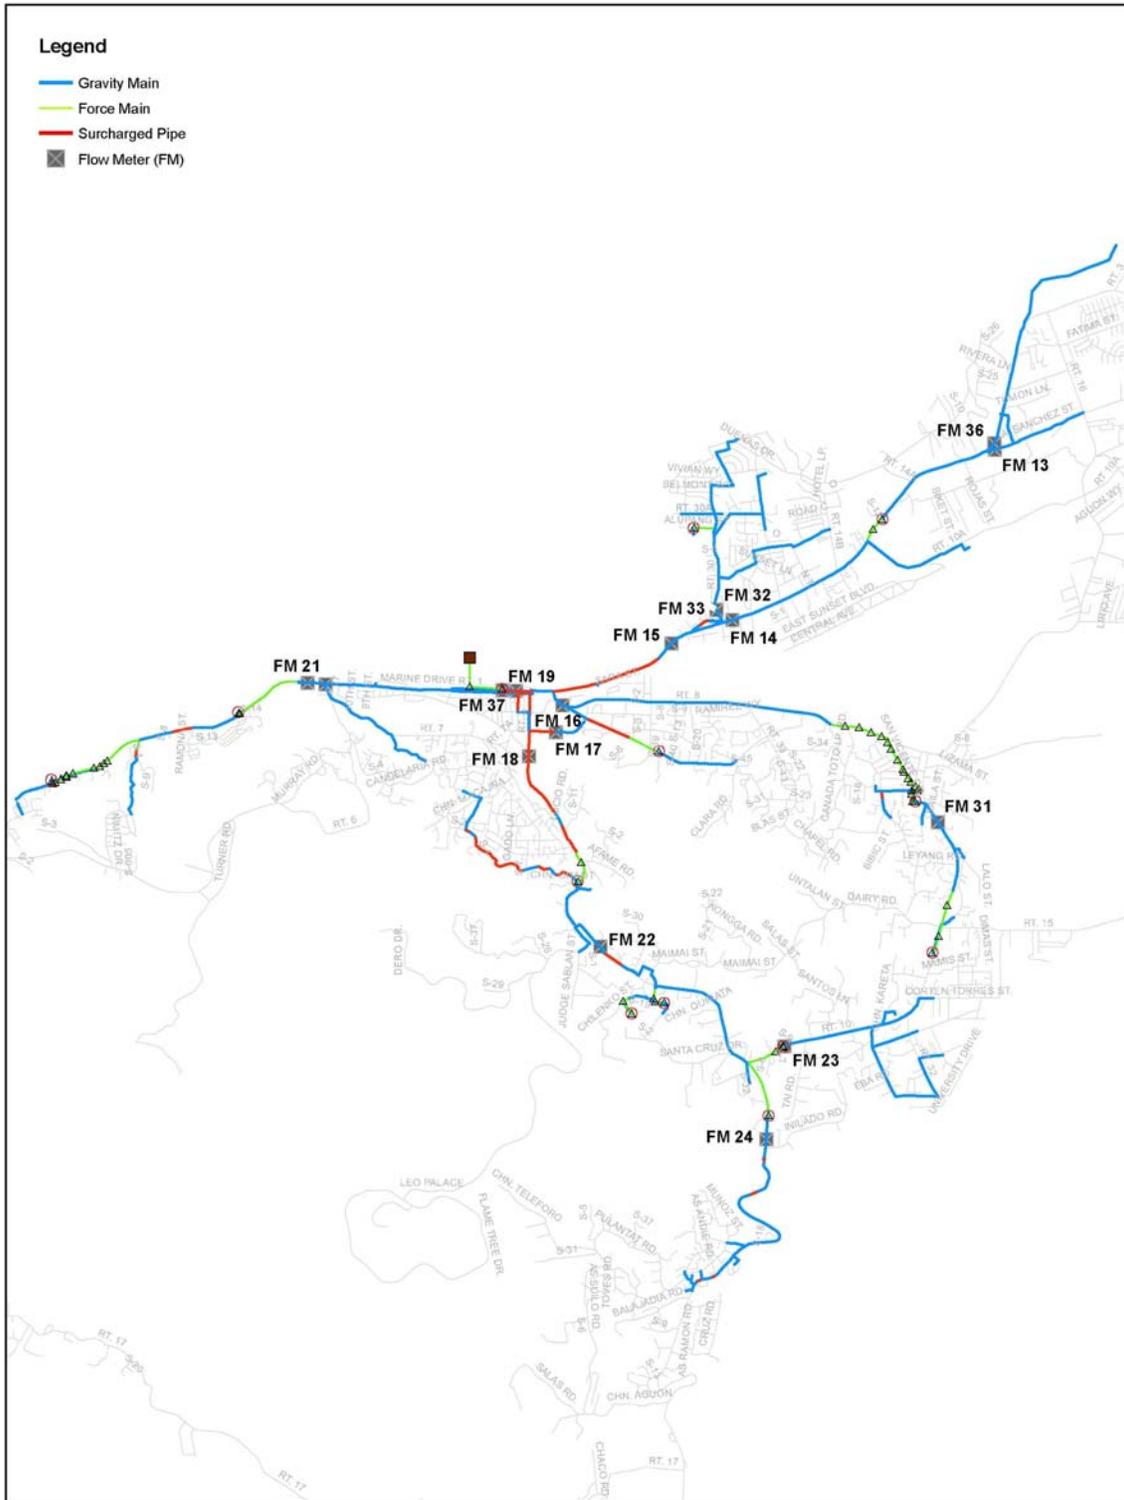
Figure 4-14 – Surcharged Sewers in the Hagatna STP Service Area

4.7.3.6.2 Hagatna STP Service Area. Figures 4-14 and 4-15 show pipes which the model predicts to be surcharged (water surface above the crown) and the estimated depth the maximum water surface is below the rim elevation for the Hagatna STP service area. Results are for the 2025 loading condition. Major problem areas are noted along Marine Drive, Route 4, Route 33, East O'Brian Drive, and the lines draining Agana Heights to the Chaot River pump station. The line is Route 33 from the Mongmong-Toto lift station to flow meter 16 is presumed and should be verified. Flows in the line draining Agana Heights to the Chaot River pump station should be metered to confirm the model projections. Some of the surcharges shown are due to downstream conditions. For example, the surcharges shown in the line draining the Tamuning area tributary to meters 32 and 33 is caused by high water levels in the line in Route 1. Likewise, the surcharges in the line on East O'Brian Drive are due to high water levels in the line Route 4.

It should be noted that the model software does not allow water to leave the system at manholes where it predicts the water surface is at the rim elevation. In the actual system, overflows up upstream manholes might relieve the system downstream so that overflows might not occur at every manhole shown with the predicted water surface at the rim. However, the model is conservative in that it predicts the impact of maintaining the flows in the system so that pipe enlargements to convey the flow to the treatment plant can be computed.

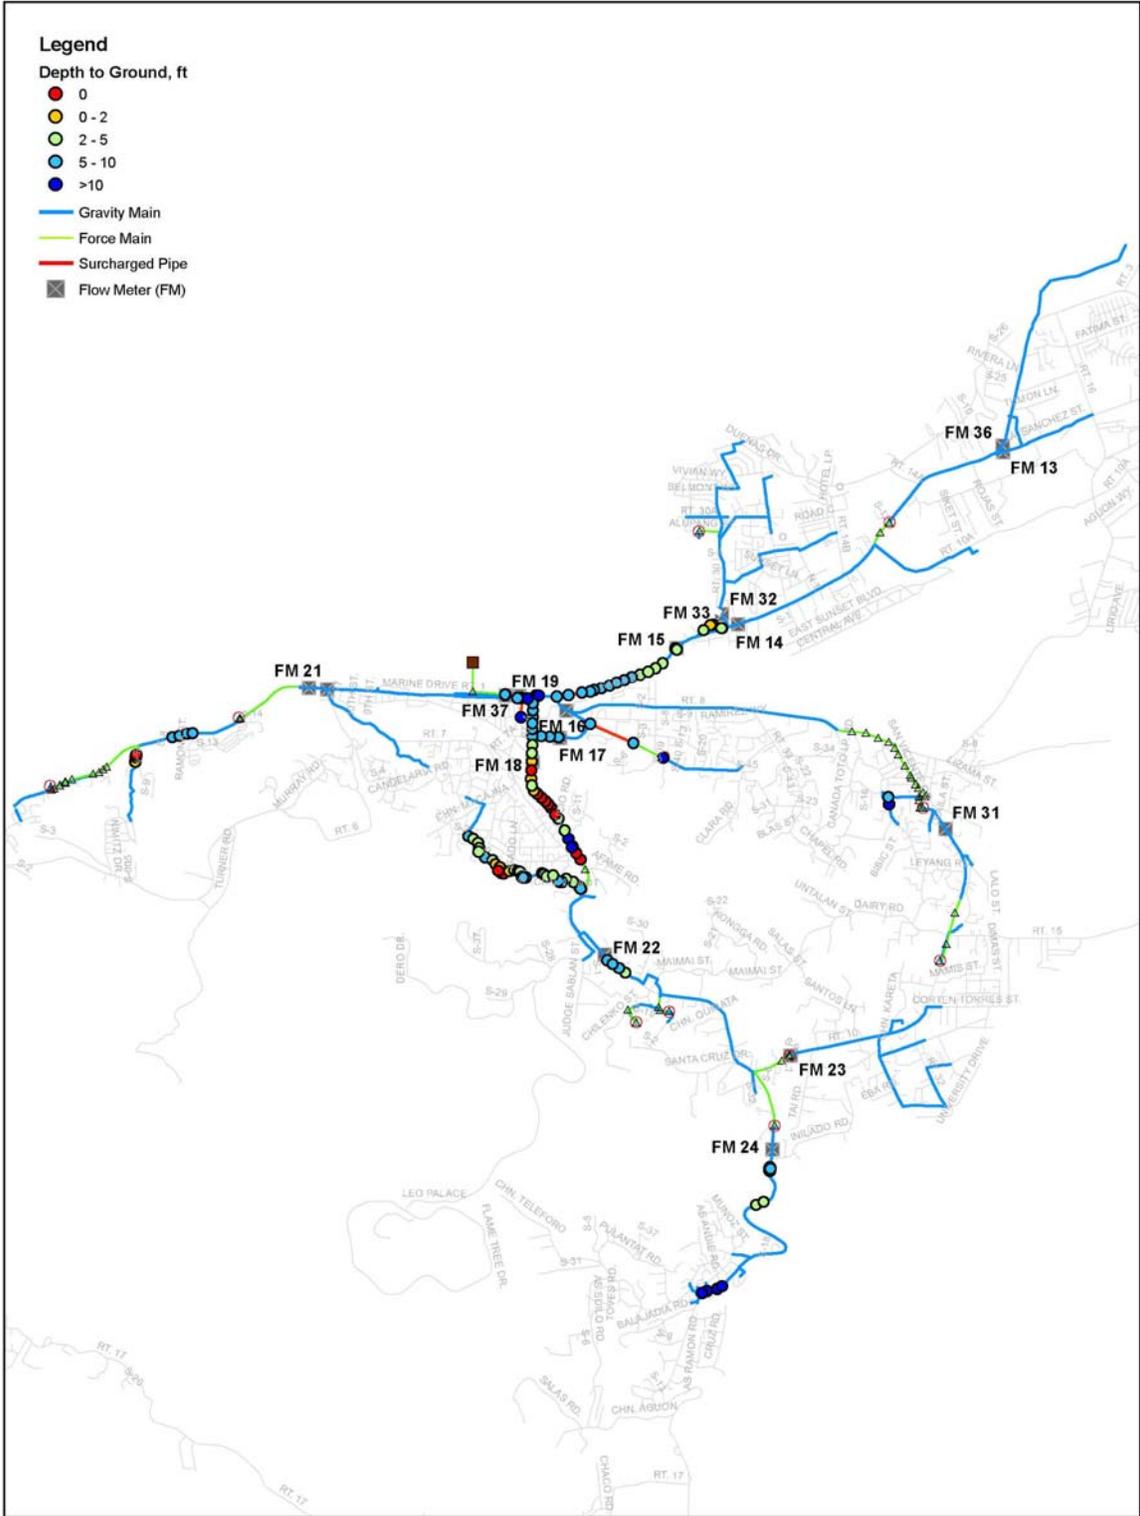
Figure 4-15 – Predicted Minimum Distance from MH Rim to Water Surface for Surcharged Sewers in the Hagatna STP Service Area

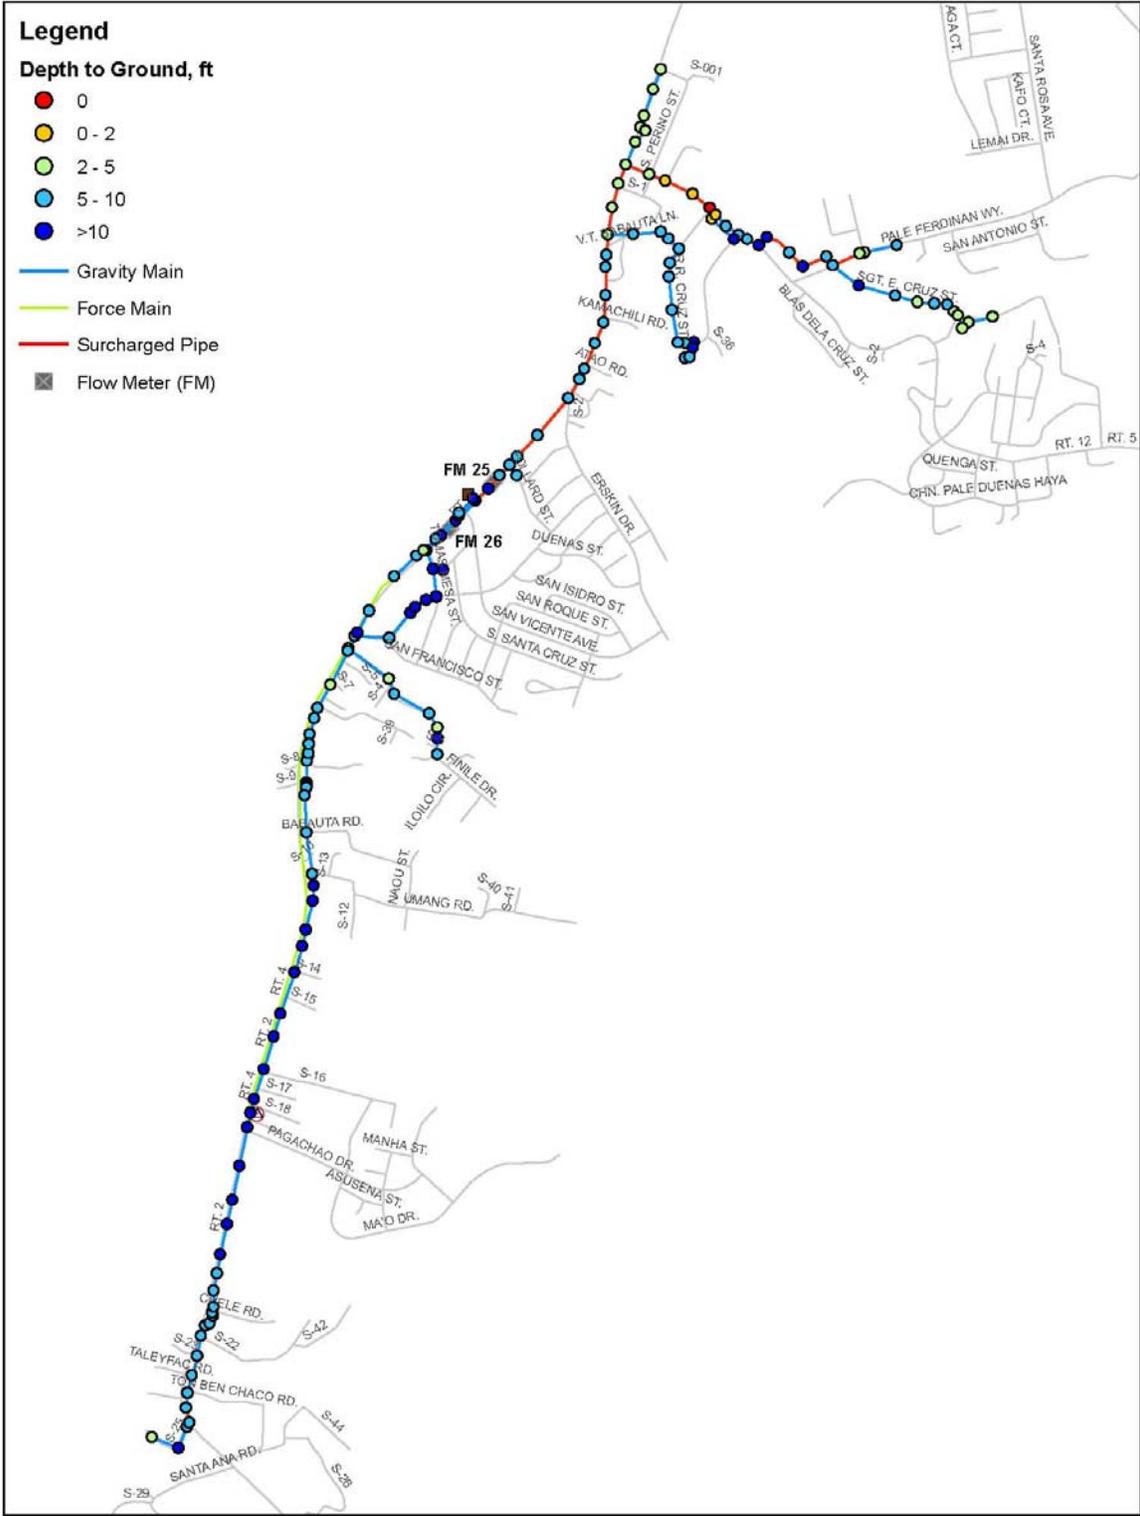
Figure 4-16 – Surcharged Sewers in the Agat-Santa Rita STP Service Area

4.7.3.6.3 Agat-Santa Rita STP Service Area. Figure 4-16 shows surcharged pipes and estimated depth the maximum water surface is below the rim for the Agat-Santa Rita STP service area. The lines tributary to flow meter 25 are shown as surcharged with the water surface near or at the surface in the area around Route 12. During the flow monitoring, both meters 25 and 26 indicated significant surcharge. It is believed this is due to the plant influent pump station not having capacity to pump all the flow. The results shown on Figure 4-16 were prepared assuming the influent pump station was upgraded to handle the flow. However, the model still predicts surcharge and potential overflow upstream of the meter 25 site. Pipe size upgrades to relieve the surcharge were computed for this area.

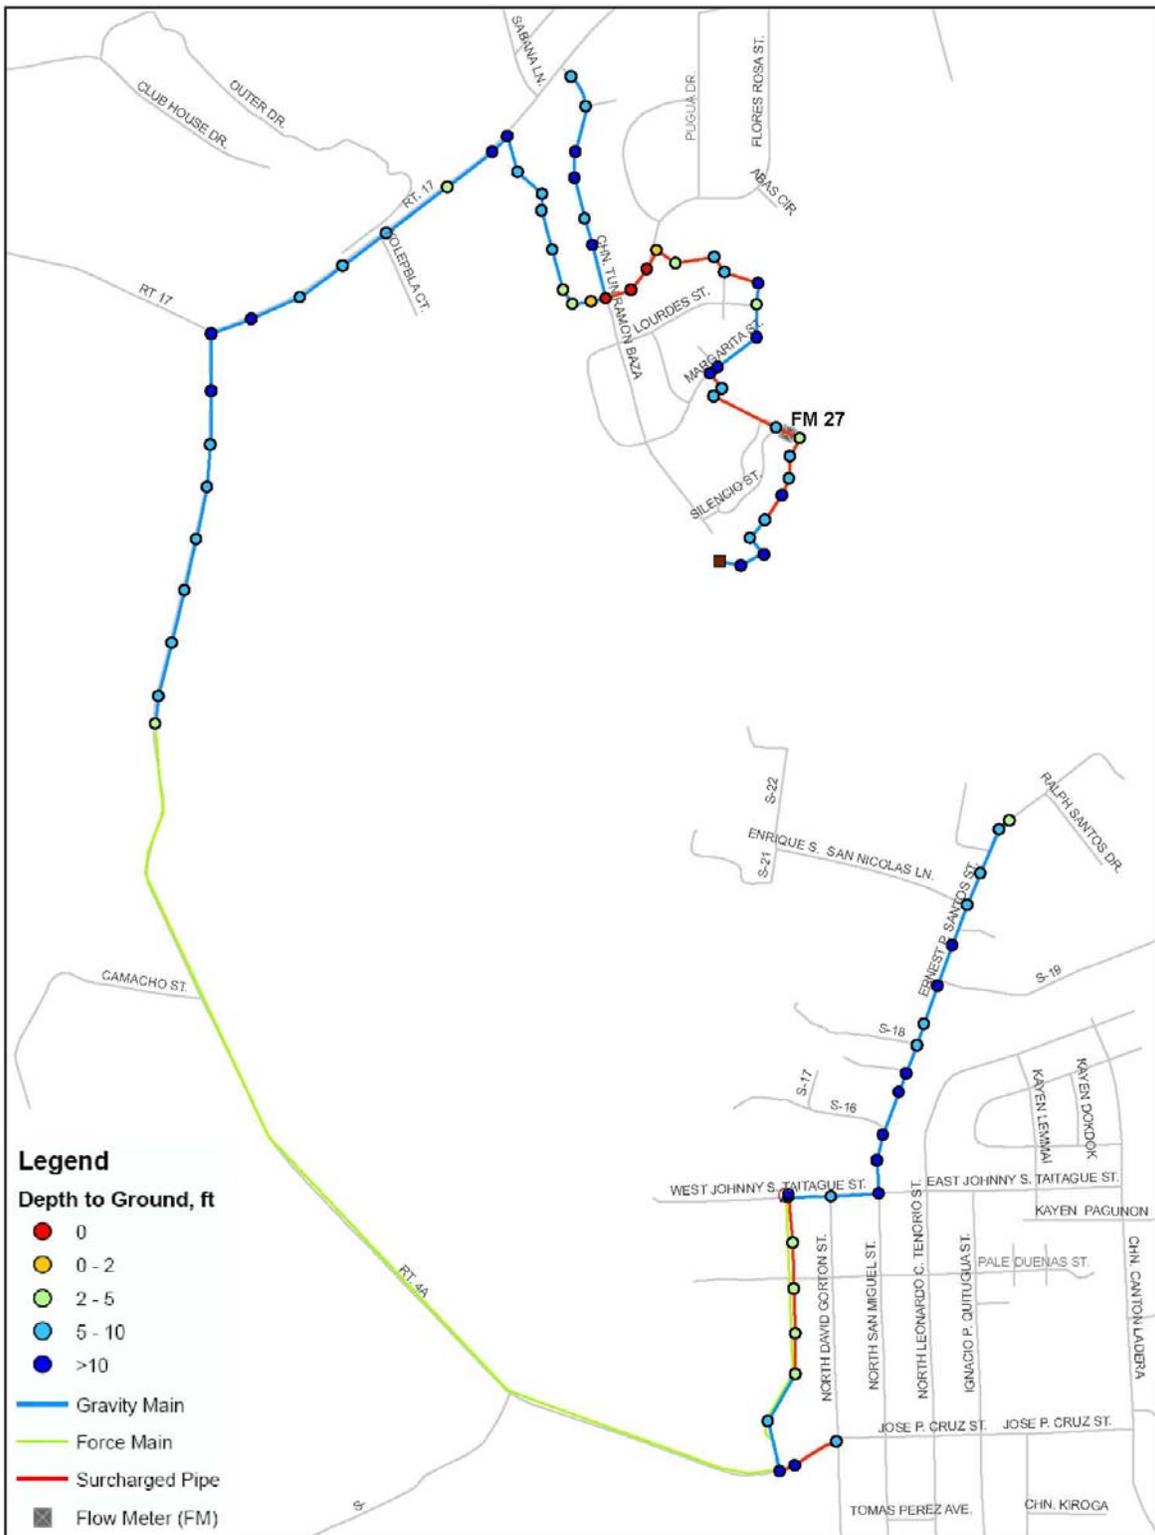
Figure 4-17 – Surcharged Sewers in the Baza Gardens STP Service Area

4.7.3.6.4 Baza Gardens STP Service Area. Figure 4-17 shows surcharged pipes and estimated depth the maximum water surface is below the rim in the Baza Gardens STP service area. Pipe sizes necessary to relieve these surcharges have been calculated. The pipes leading the plant in Flores Rosa Street will have to be addressed when the developed areas not yet connected to the system are added.
